A Summary of the Galaxy 15 Incident and its Impact on Space Sustainability

Brian Weeden
Technical Advisor
Secure World Foundation

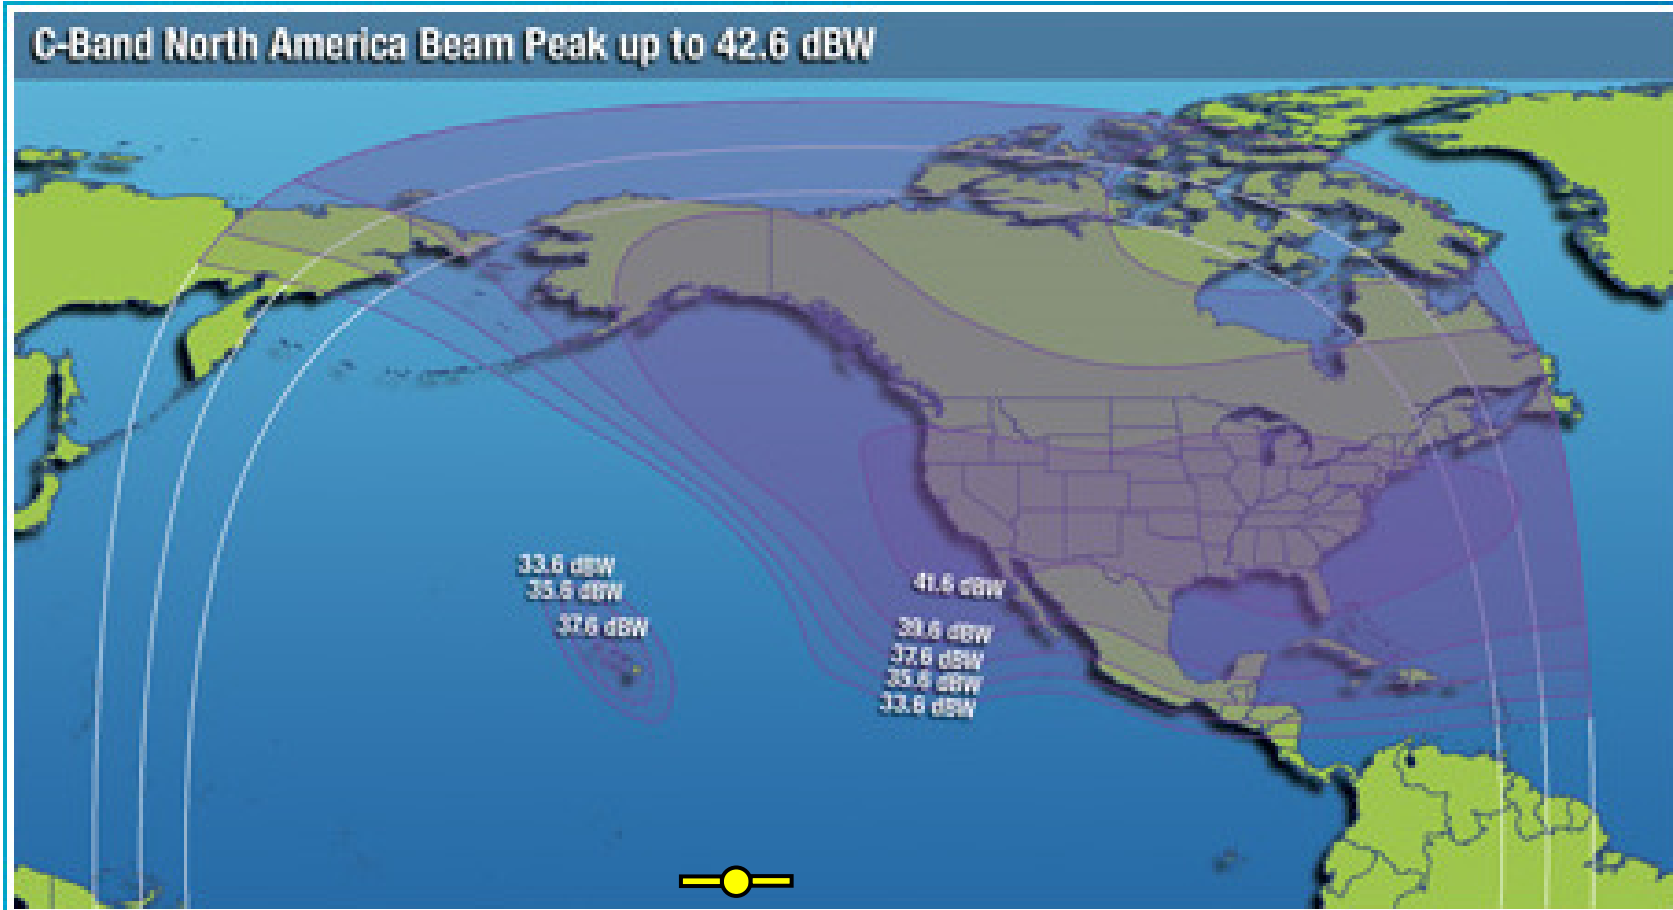
- April, 2010, Galaxy 15 stopped responding to commands and transmitting telemetry
- Galaxy 15's communications payload remained active and was able to rebroadcast any C-band signals it received while drifting
 - “Open microphone”

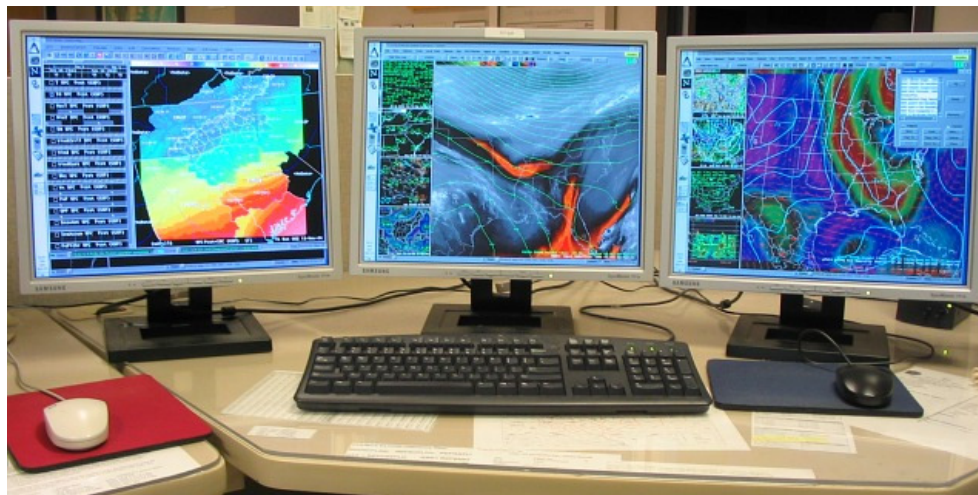
- Galaxy 15 drifted past SES-1 satellite from 4-18 Dec, 2010
 - SES-1 relays data from several US weather tracking and forecasting satellites to US National Weather Service (NWS)
 - Interference from Galaxy 15 caused a brief outage with the satellite data feed on 6 Dec
