# Development and Operation of a GPS Jammer Localization System at the Airport

Deok Won Lim  
Korea Aerospace Research Institute

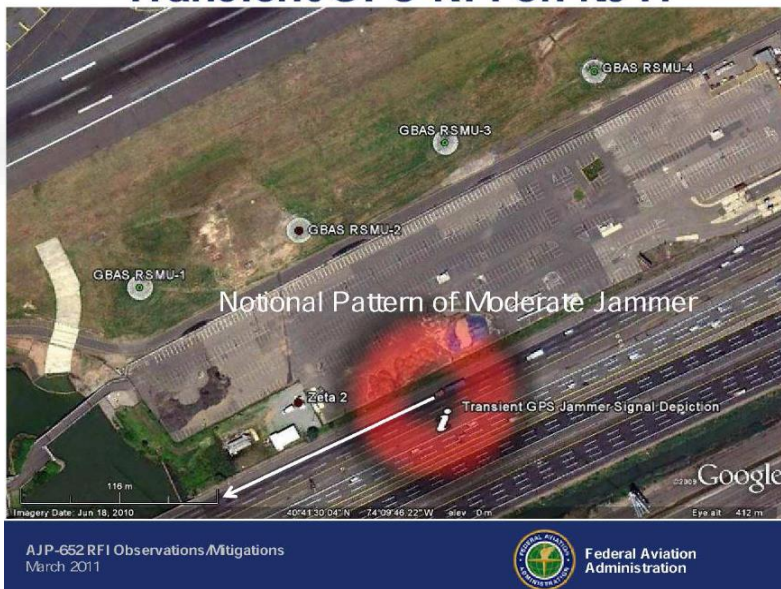
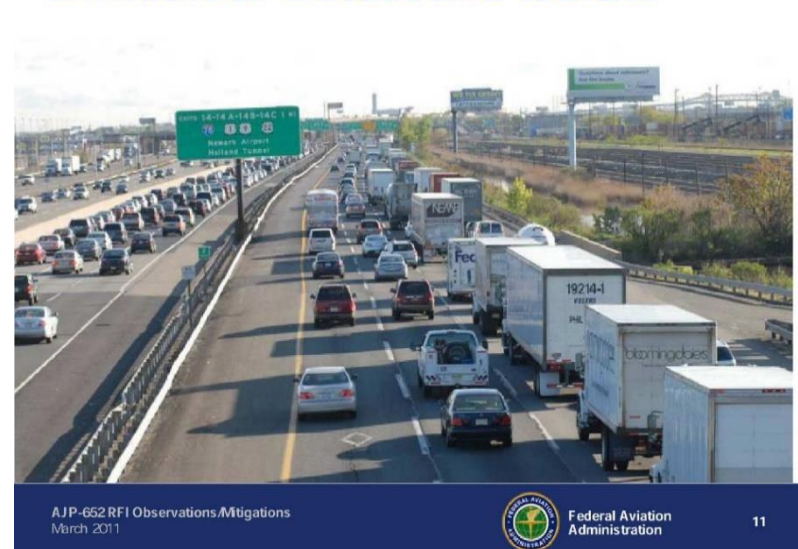
- Newark airport in 2010
  - LGF(LAAS Ground Facility) was jammed
  - From PPD(Personal Privacy Devices)

### Transient GPS RFI on NJTP

### Difficult to Detect and Isolate

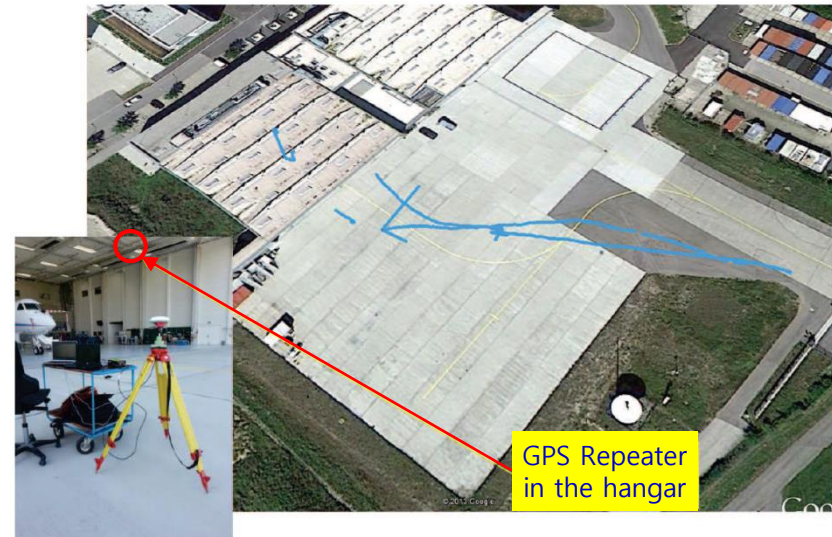
- Hannover airport in 2010
  - Enhanced Ground Proximity was jammed
  - Due to the GPS repeater

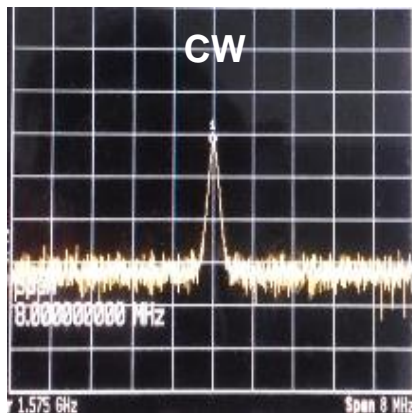
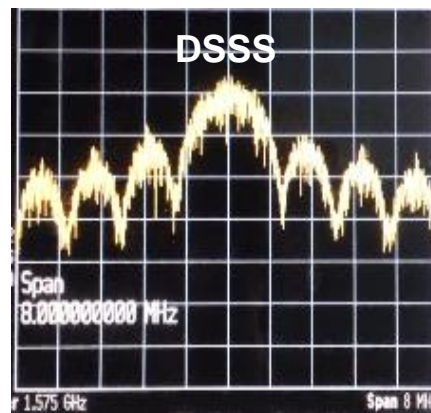
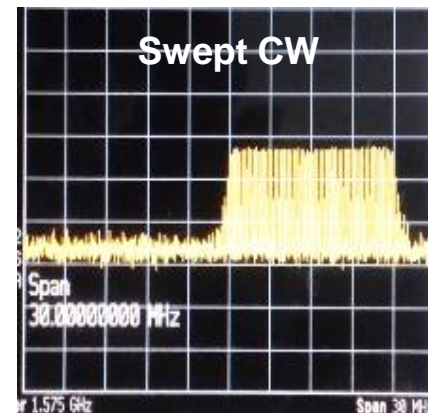
Type of jamming signals	
CW	- Single tone signal - <b>Used by North Korea mostly</b>
DSSS	- GPS-like signals - <b>Used at Hannover airport</b>
Swept CW	- Frequency varying CW signal - <b>Used at Newark airport</b>

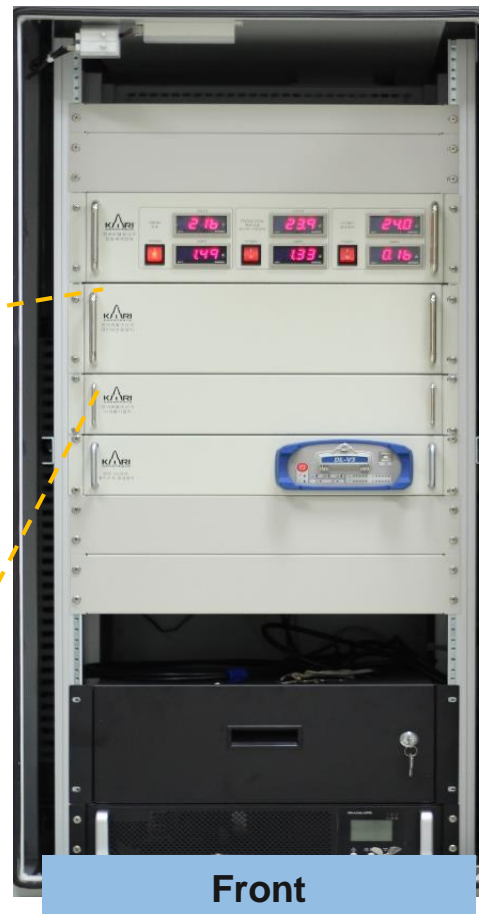
Front

- Includes array antenna, RF/IF and digital circuits and other sensors

Array antenna

RF/IF Circuits

Digital Circuits

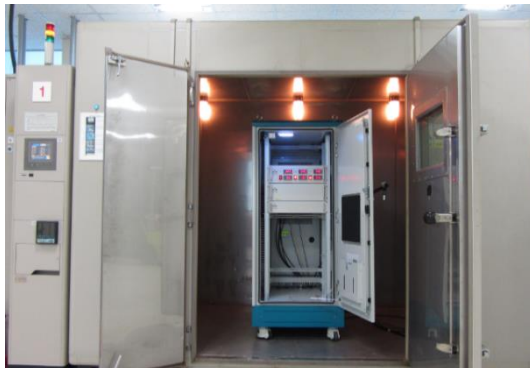
Temperature Chamber

- Verification of functionality
- Verification of RF channel mismatches in RF/IF circuits

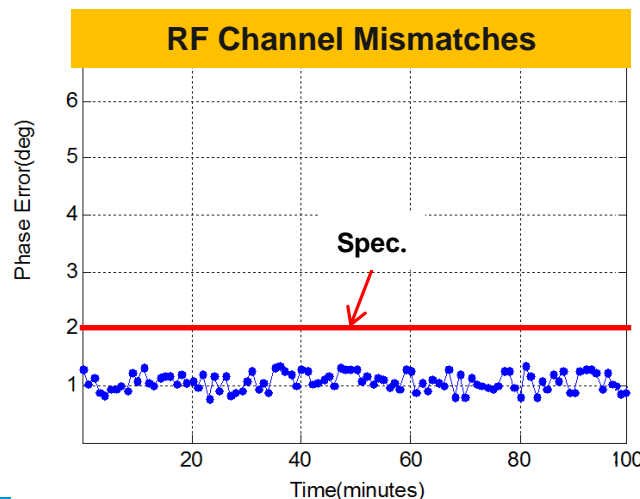
Channel mismatch error:  
1.2 deg. (rms)

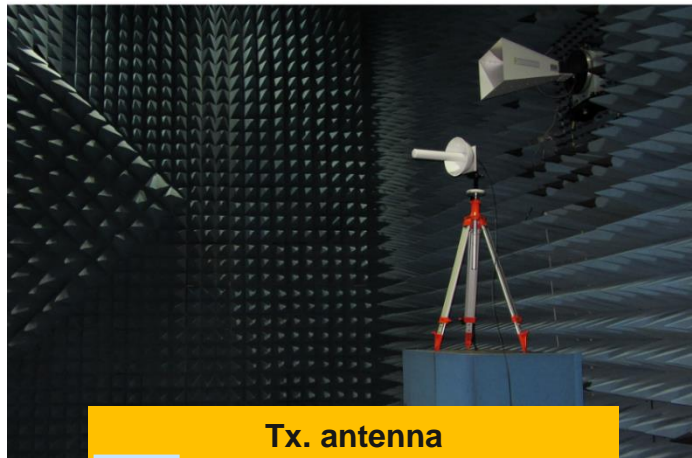
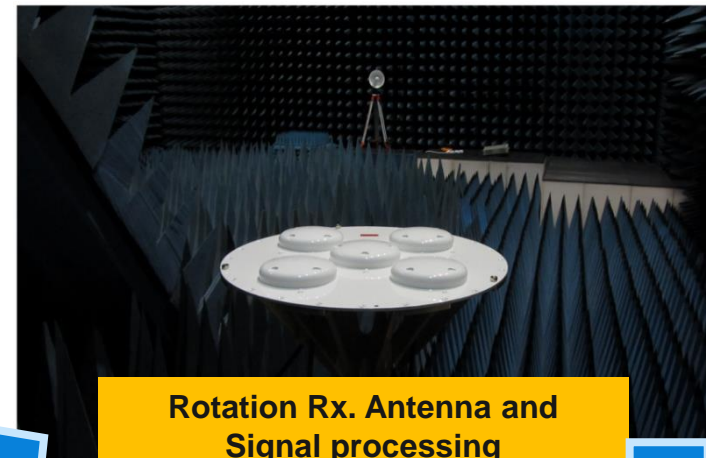
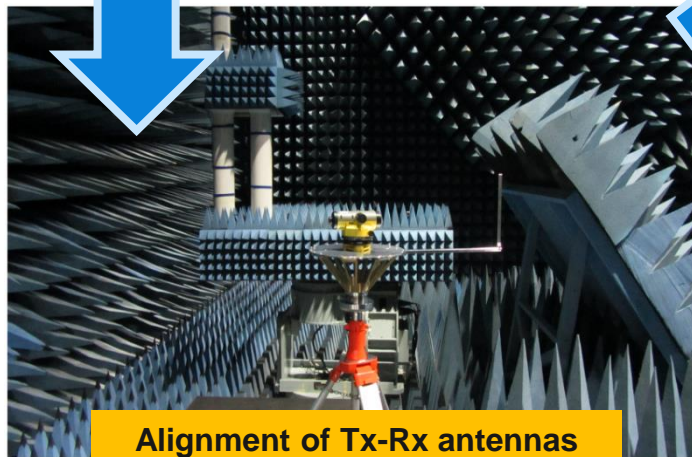
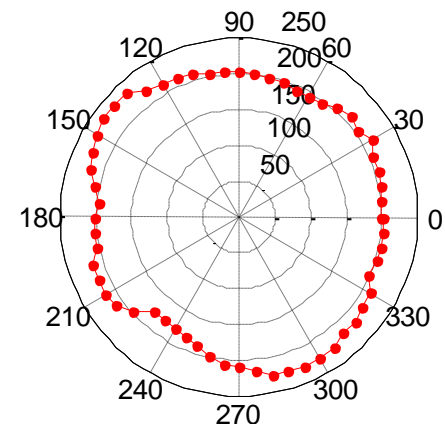
- Measuring antenna mismatches in an anechoic chamber

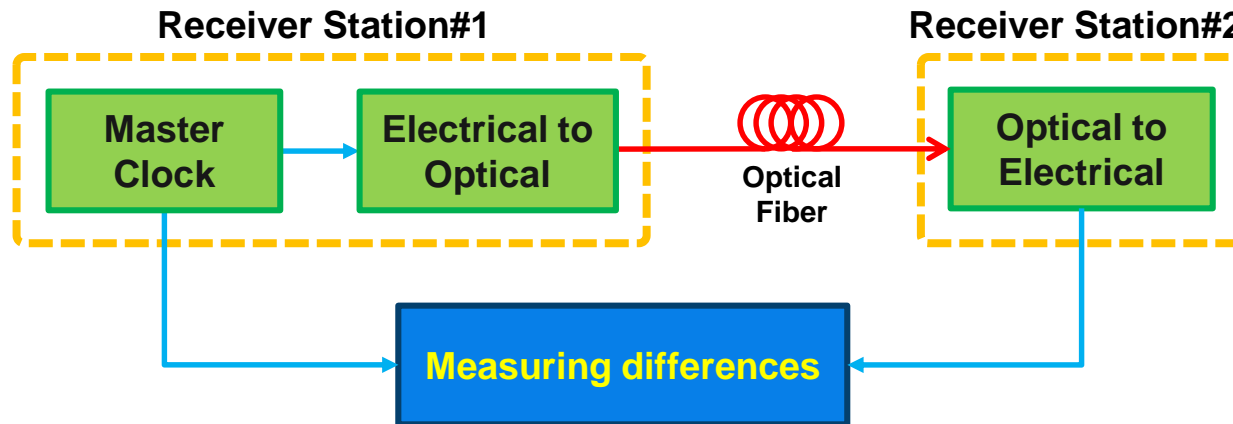
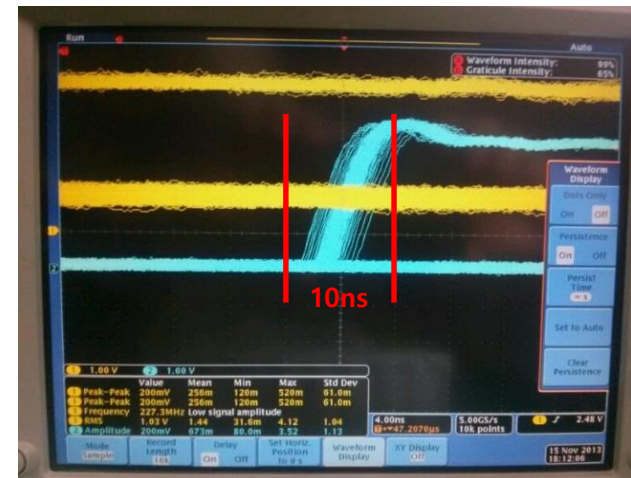
- Performance of time synchronization between Receiver Stations

**Time sync. error : 4.8ns (rms)**

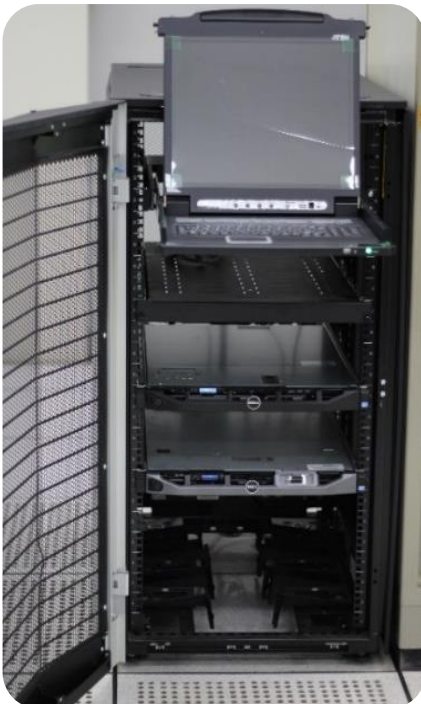
Sever rack

- Central Processing Station
  - Includes Linux servers for algorithm processing and web-browser
- Monitoring Station

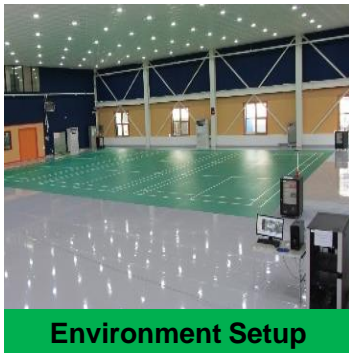
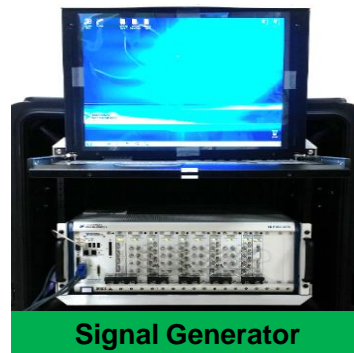
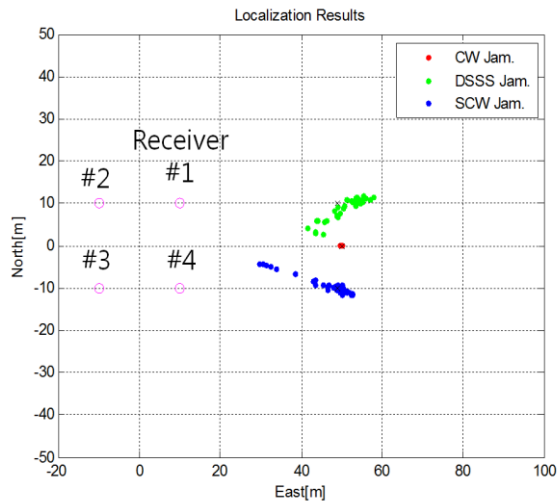
- System verification in indoor environment

<The localization results in 1/200 scale down and real-time environment>

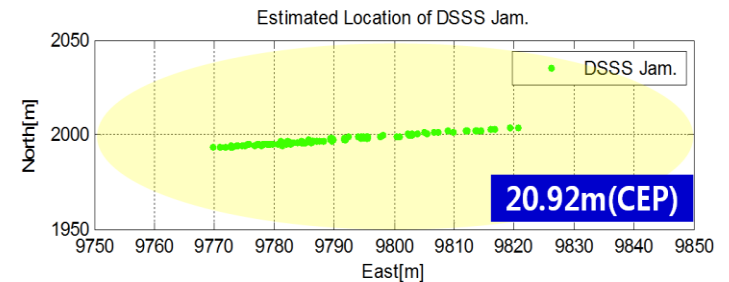
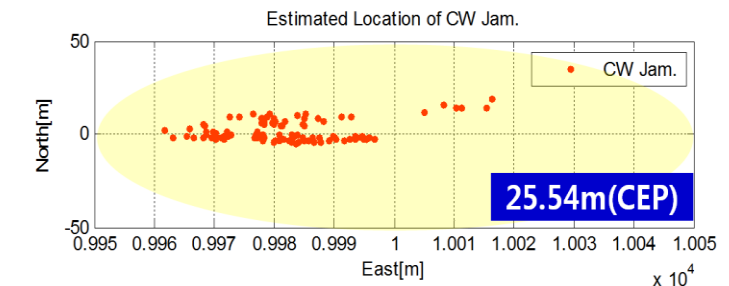
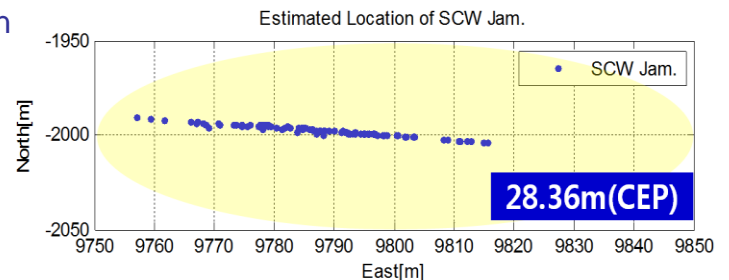
Applying measurement error in real environment

<The expectation results of positioning in real environment>

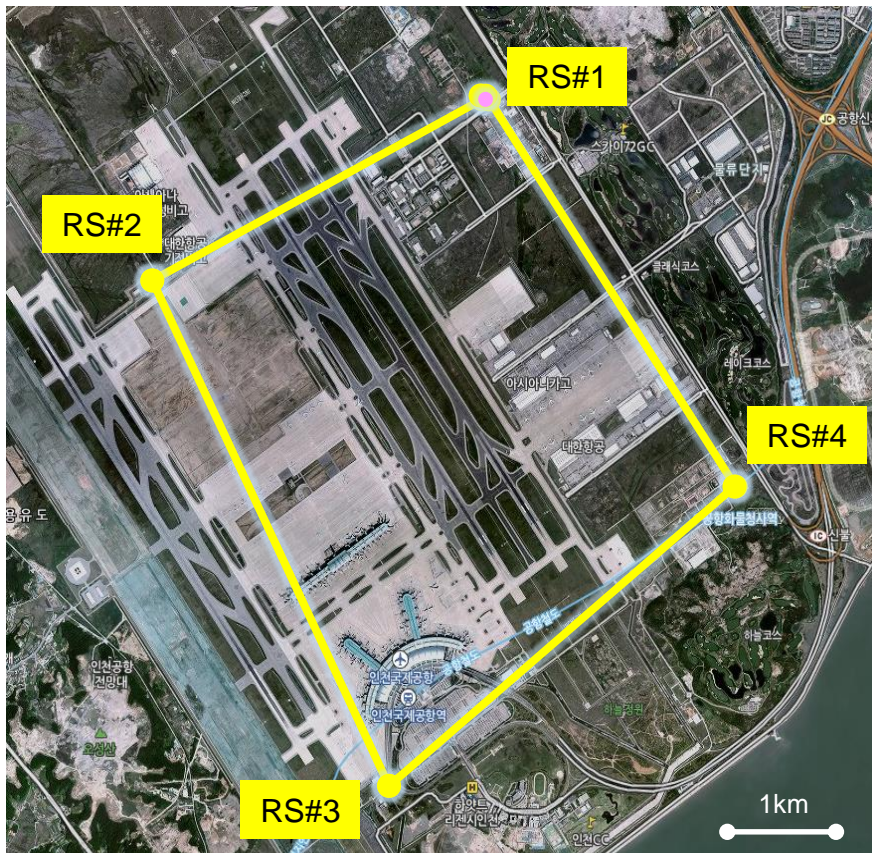
### Locations of Receiver Stations

- In Incheon International Airport in Nov. 2014

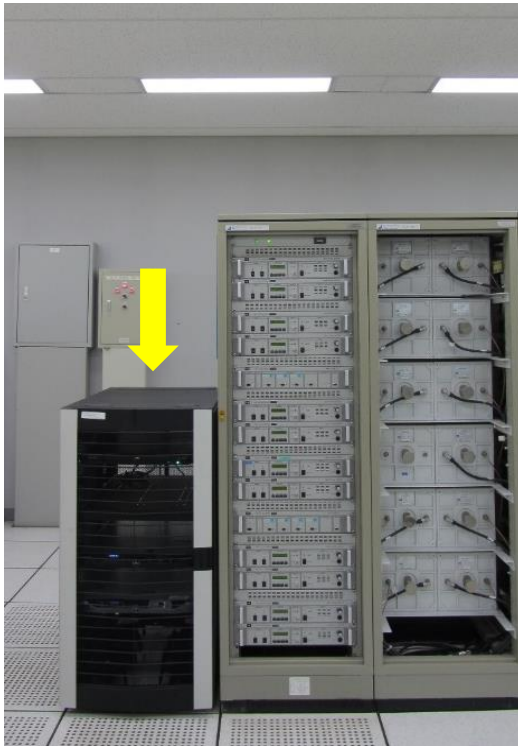
### Central Processing Station and Monitoring Station

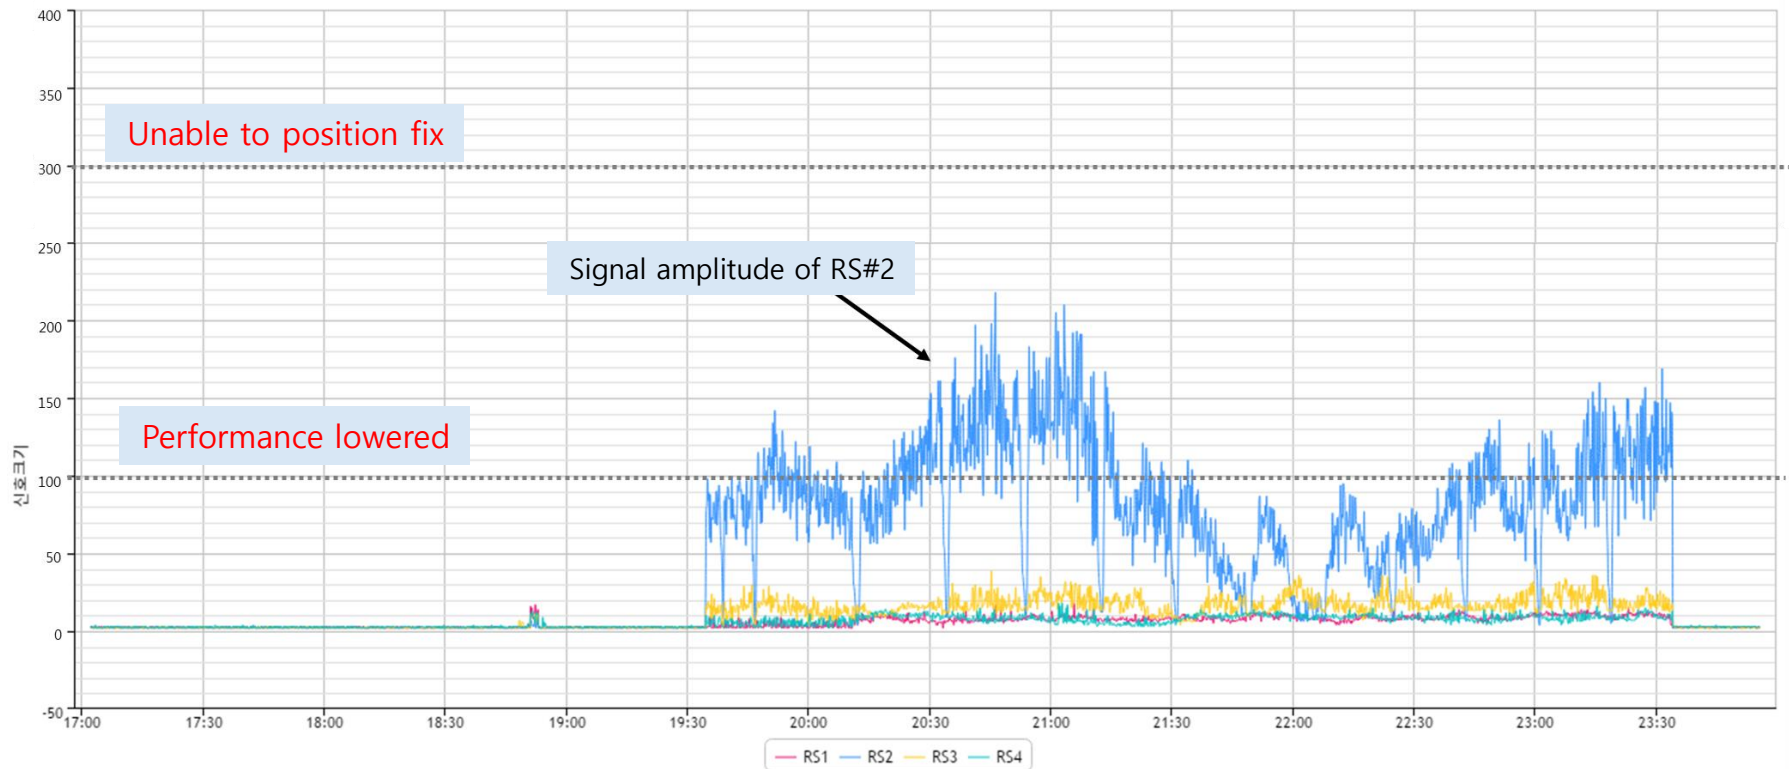
- Signal amplitude on Mar. 31, 2016
  - Since 19:35, jamming signal was detected
  - Signals received at RS#2 were stronger than the others

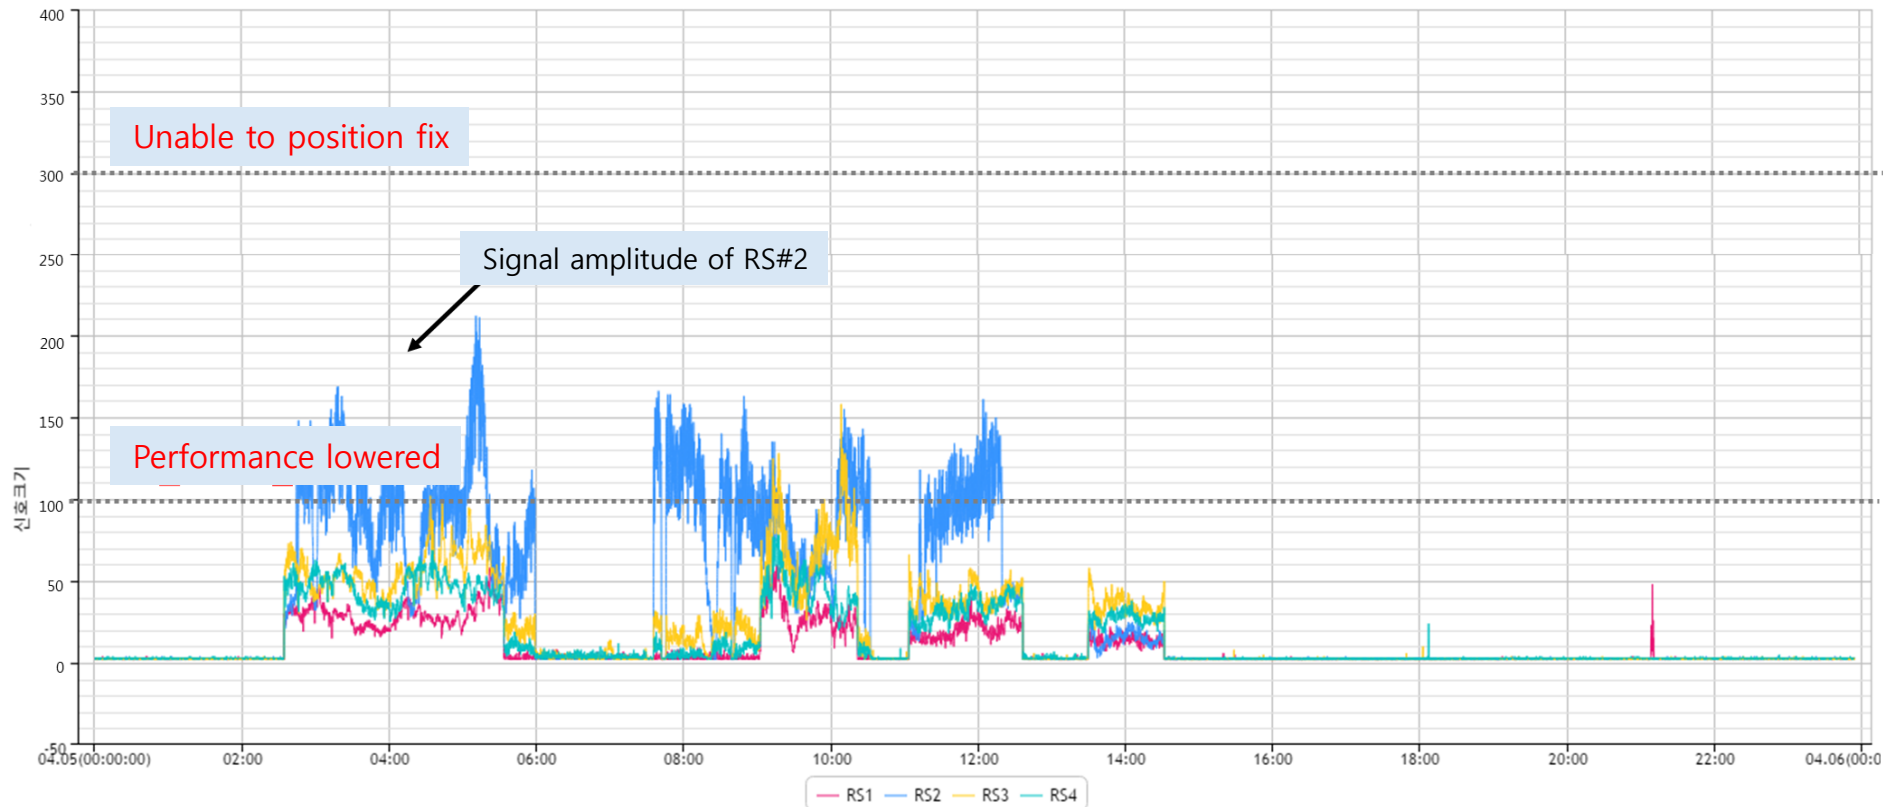
- Signal amplitude in Apr. 5, 2016
  - Ended after 14:30

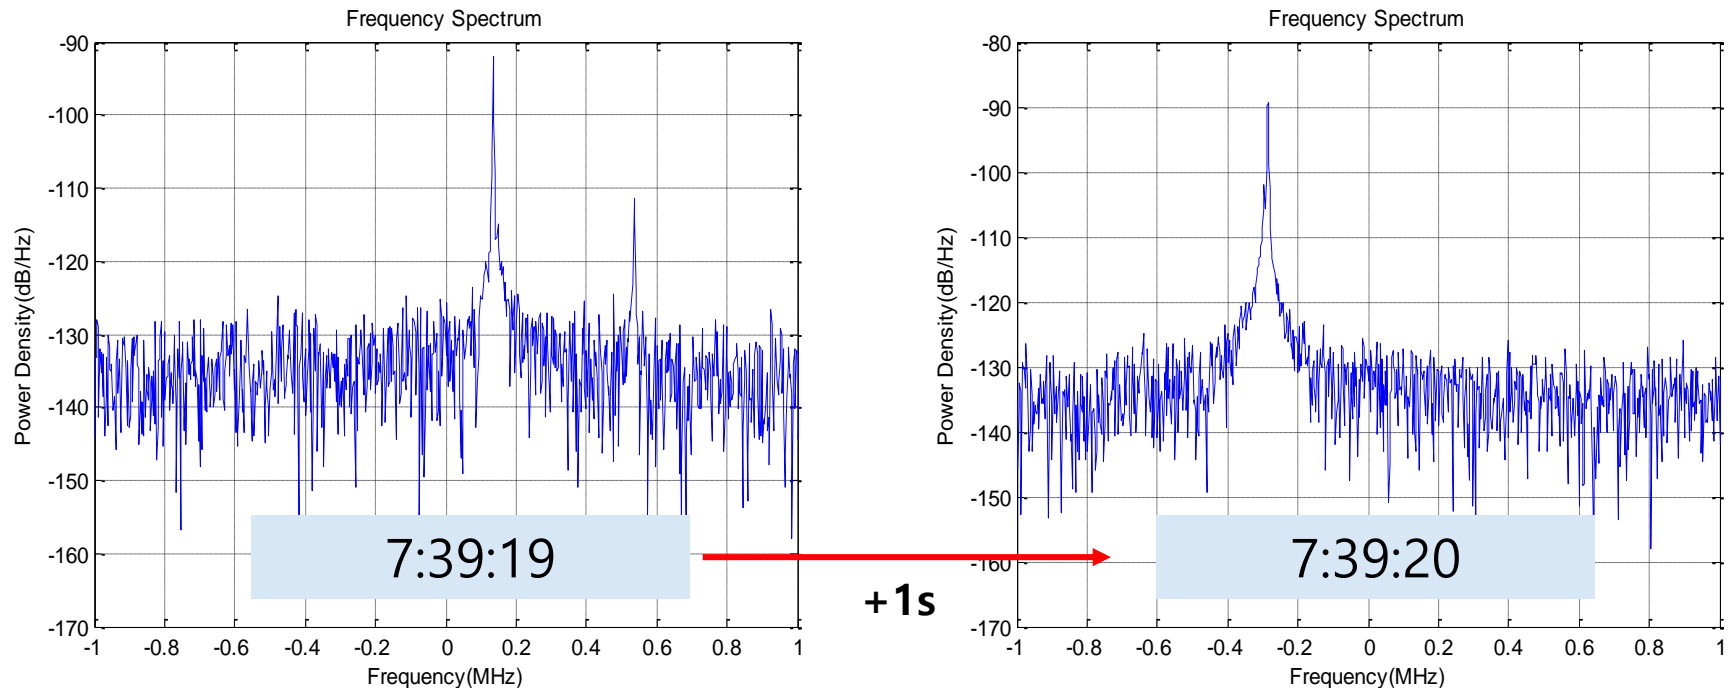
- Characteristics of jamming signal
  - Frequency spectrums of signals at 7:38:19 and 7:38:20
  - Jamming signals were time-varying or hopping and with multiple signals
