Space Technology Application for Wenchuan Earthquake Relief

Dr. Li Suju

National Disaster Reduction Center of China
Feb 13, 2009 Vienna

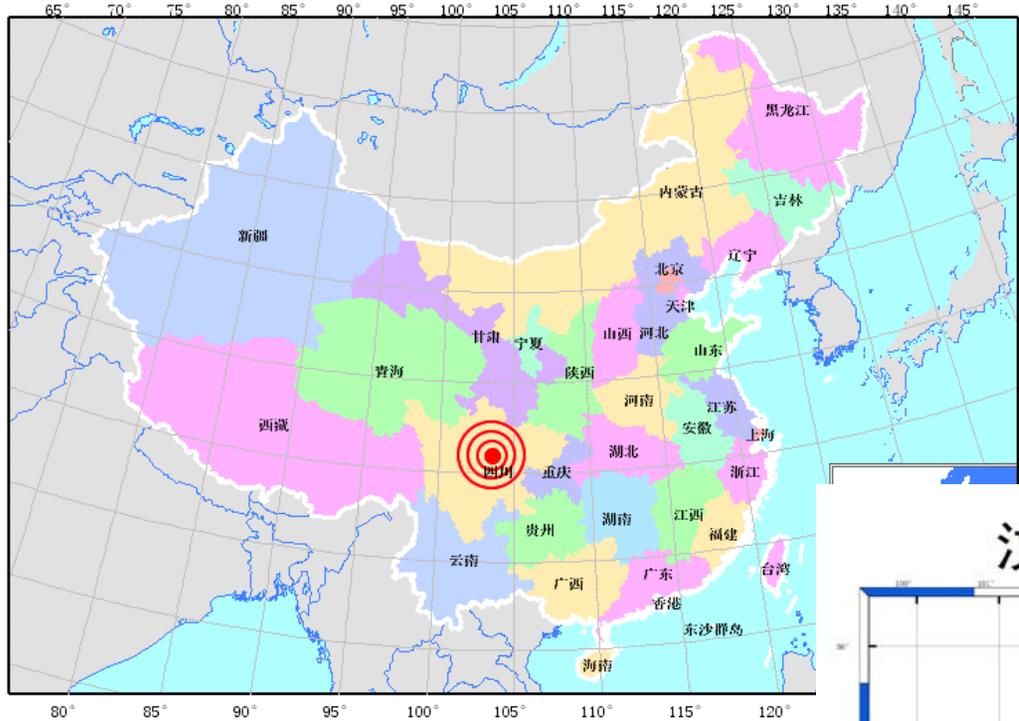
汶川8.0级地震烈度分布图

- ◆ Time: 14:28 Beijing Time
- ◆ Date: May 12, 2008
- ◆ Location: Wenchuan, Sichuan Province, China
- ◆ Epicenter: 31.021N, 103.367E
- ◆ Magnitude: 8.0M on Richter scale

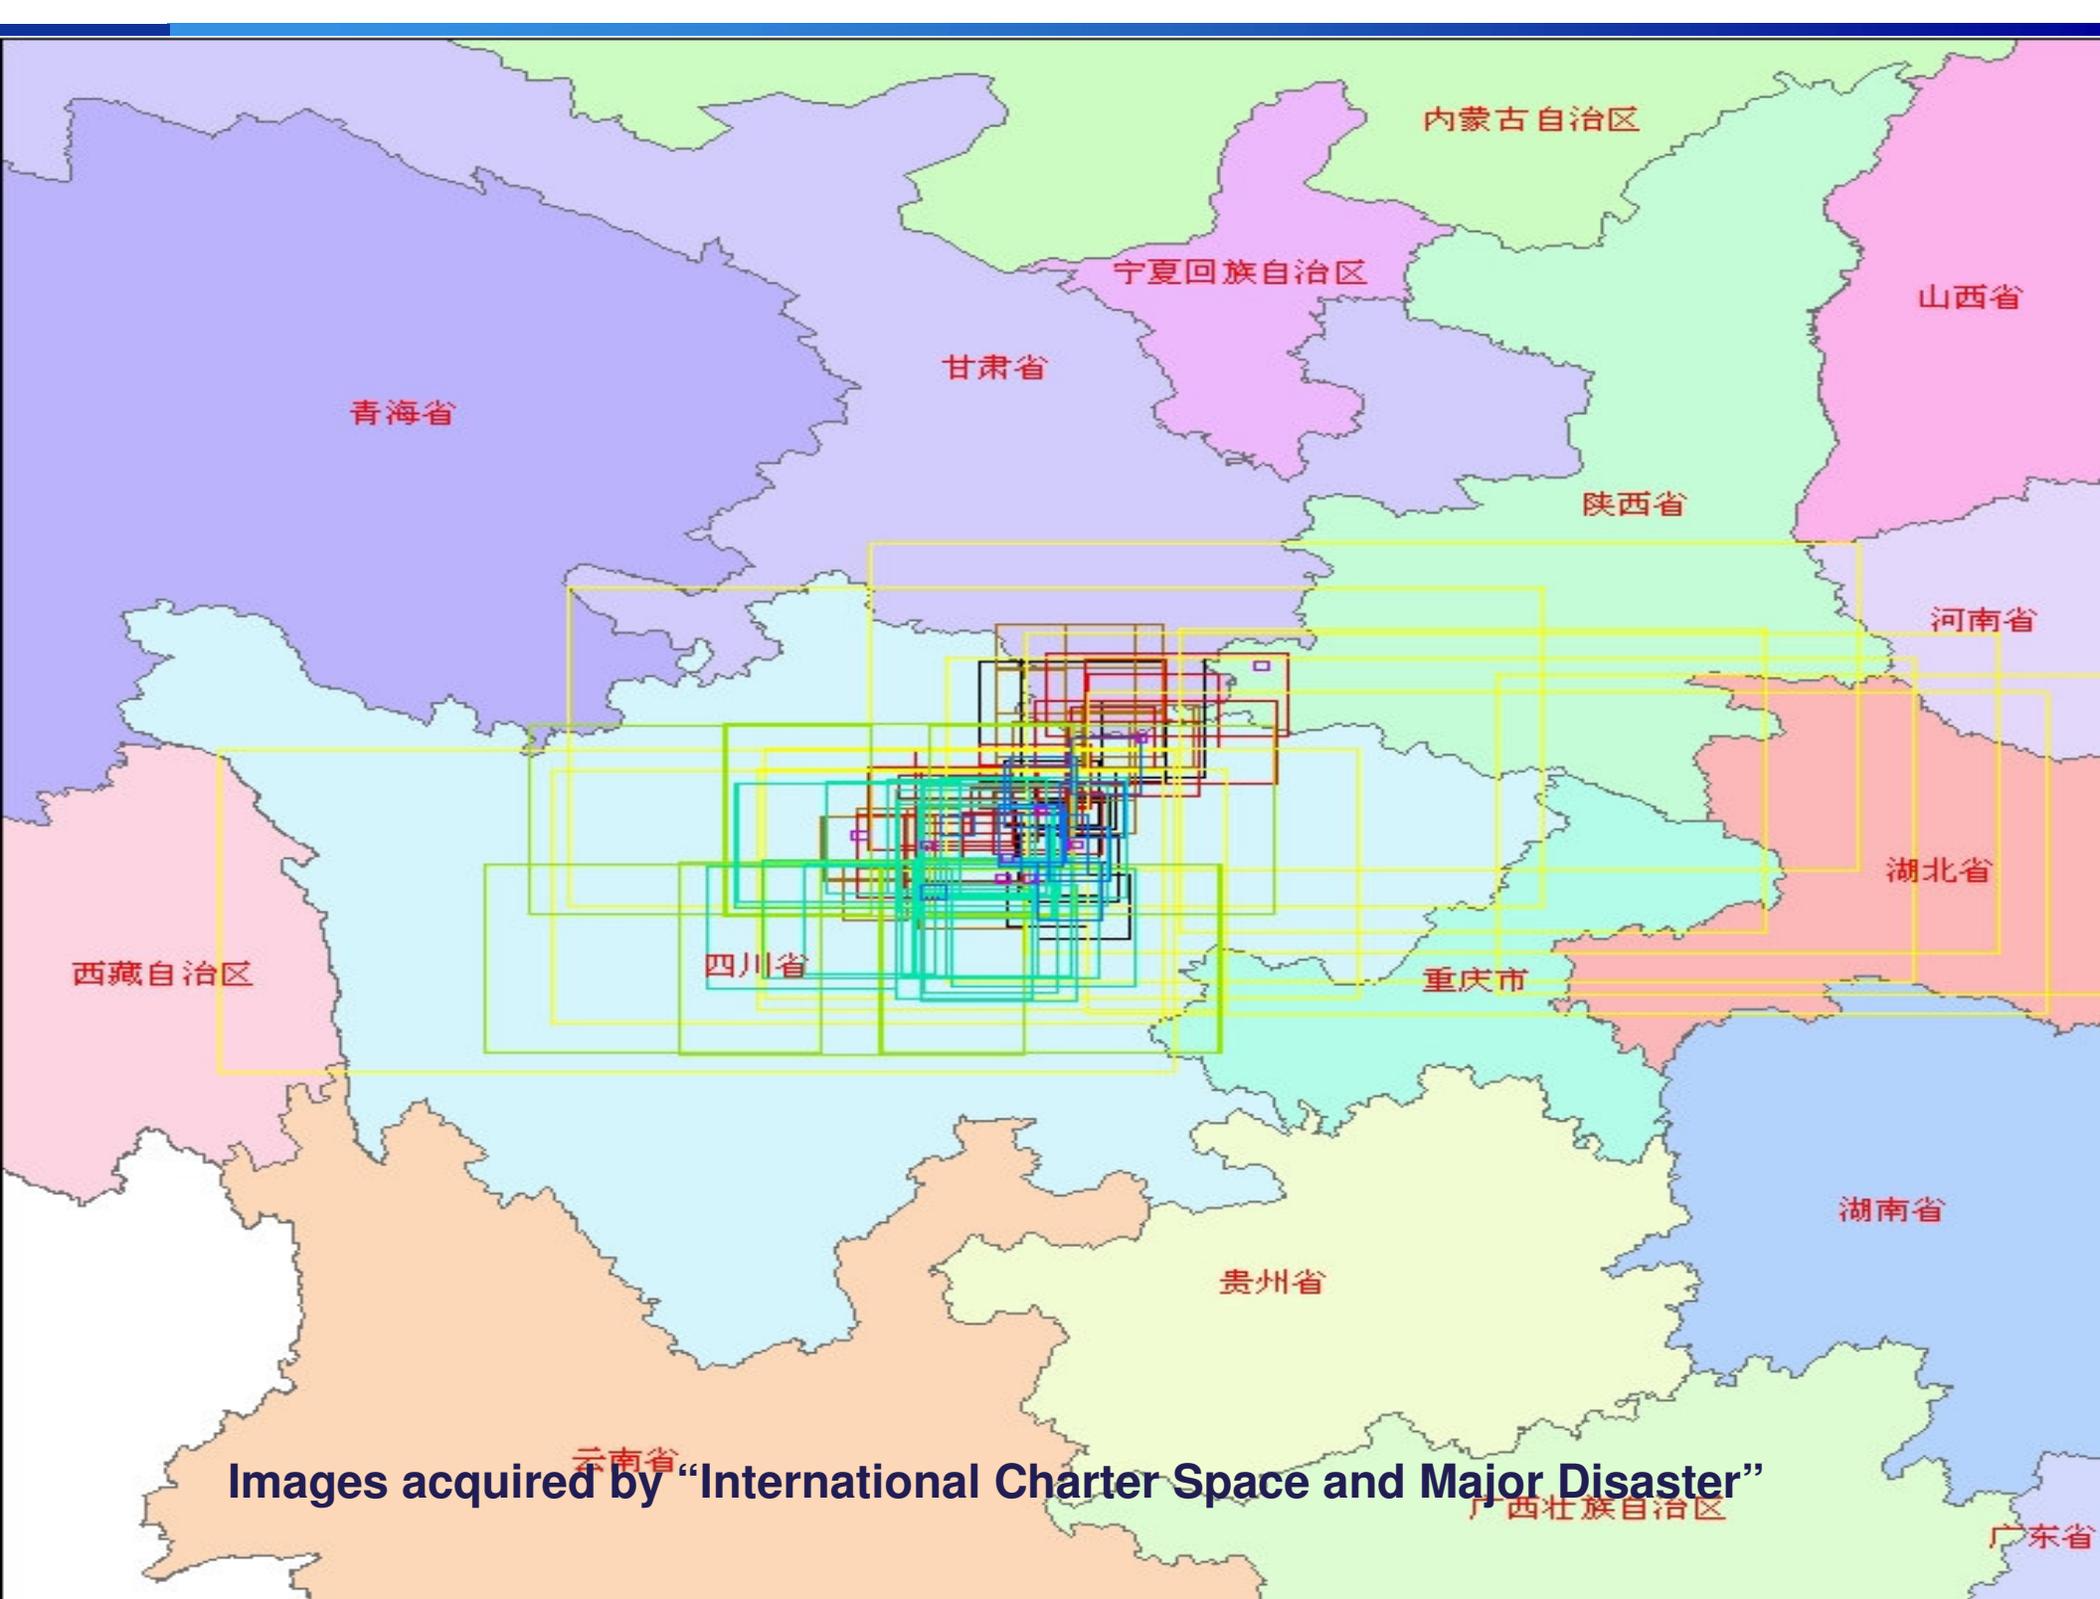
Images acquired by “International Charter Space and Major Disaster”

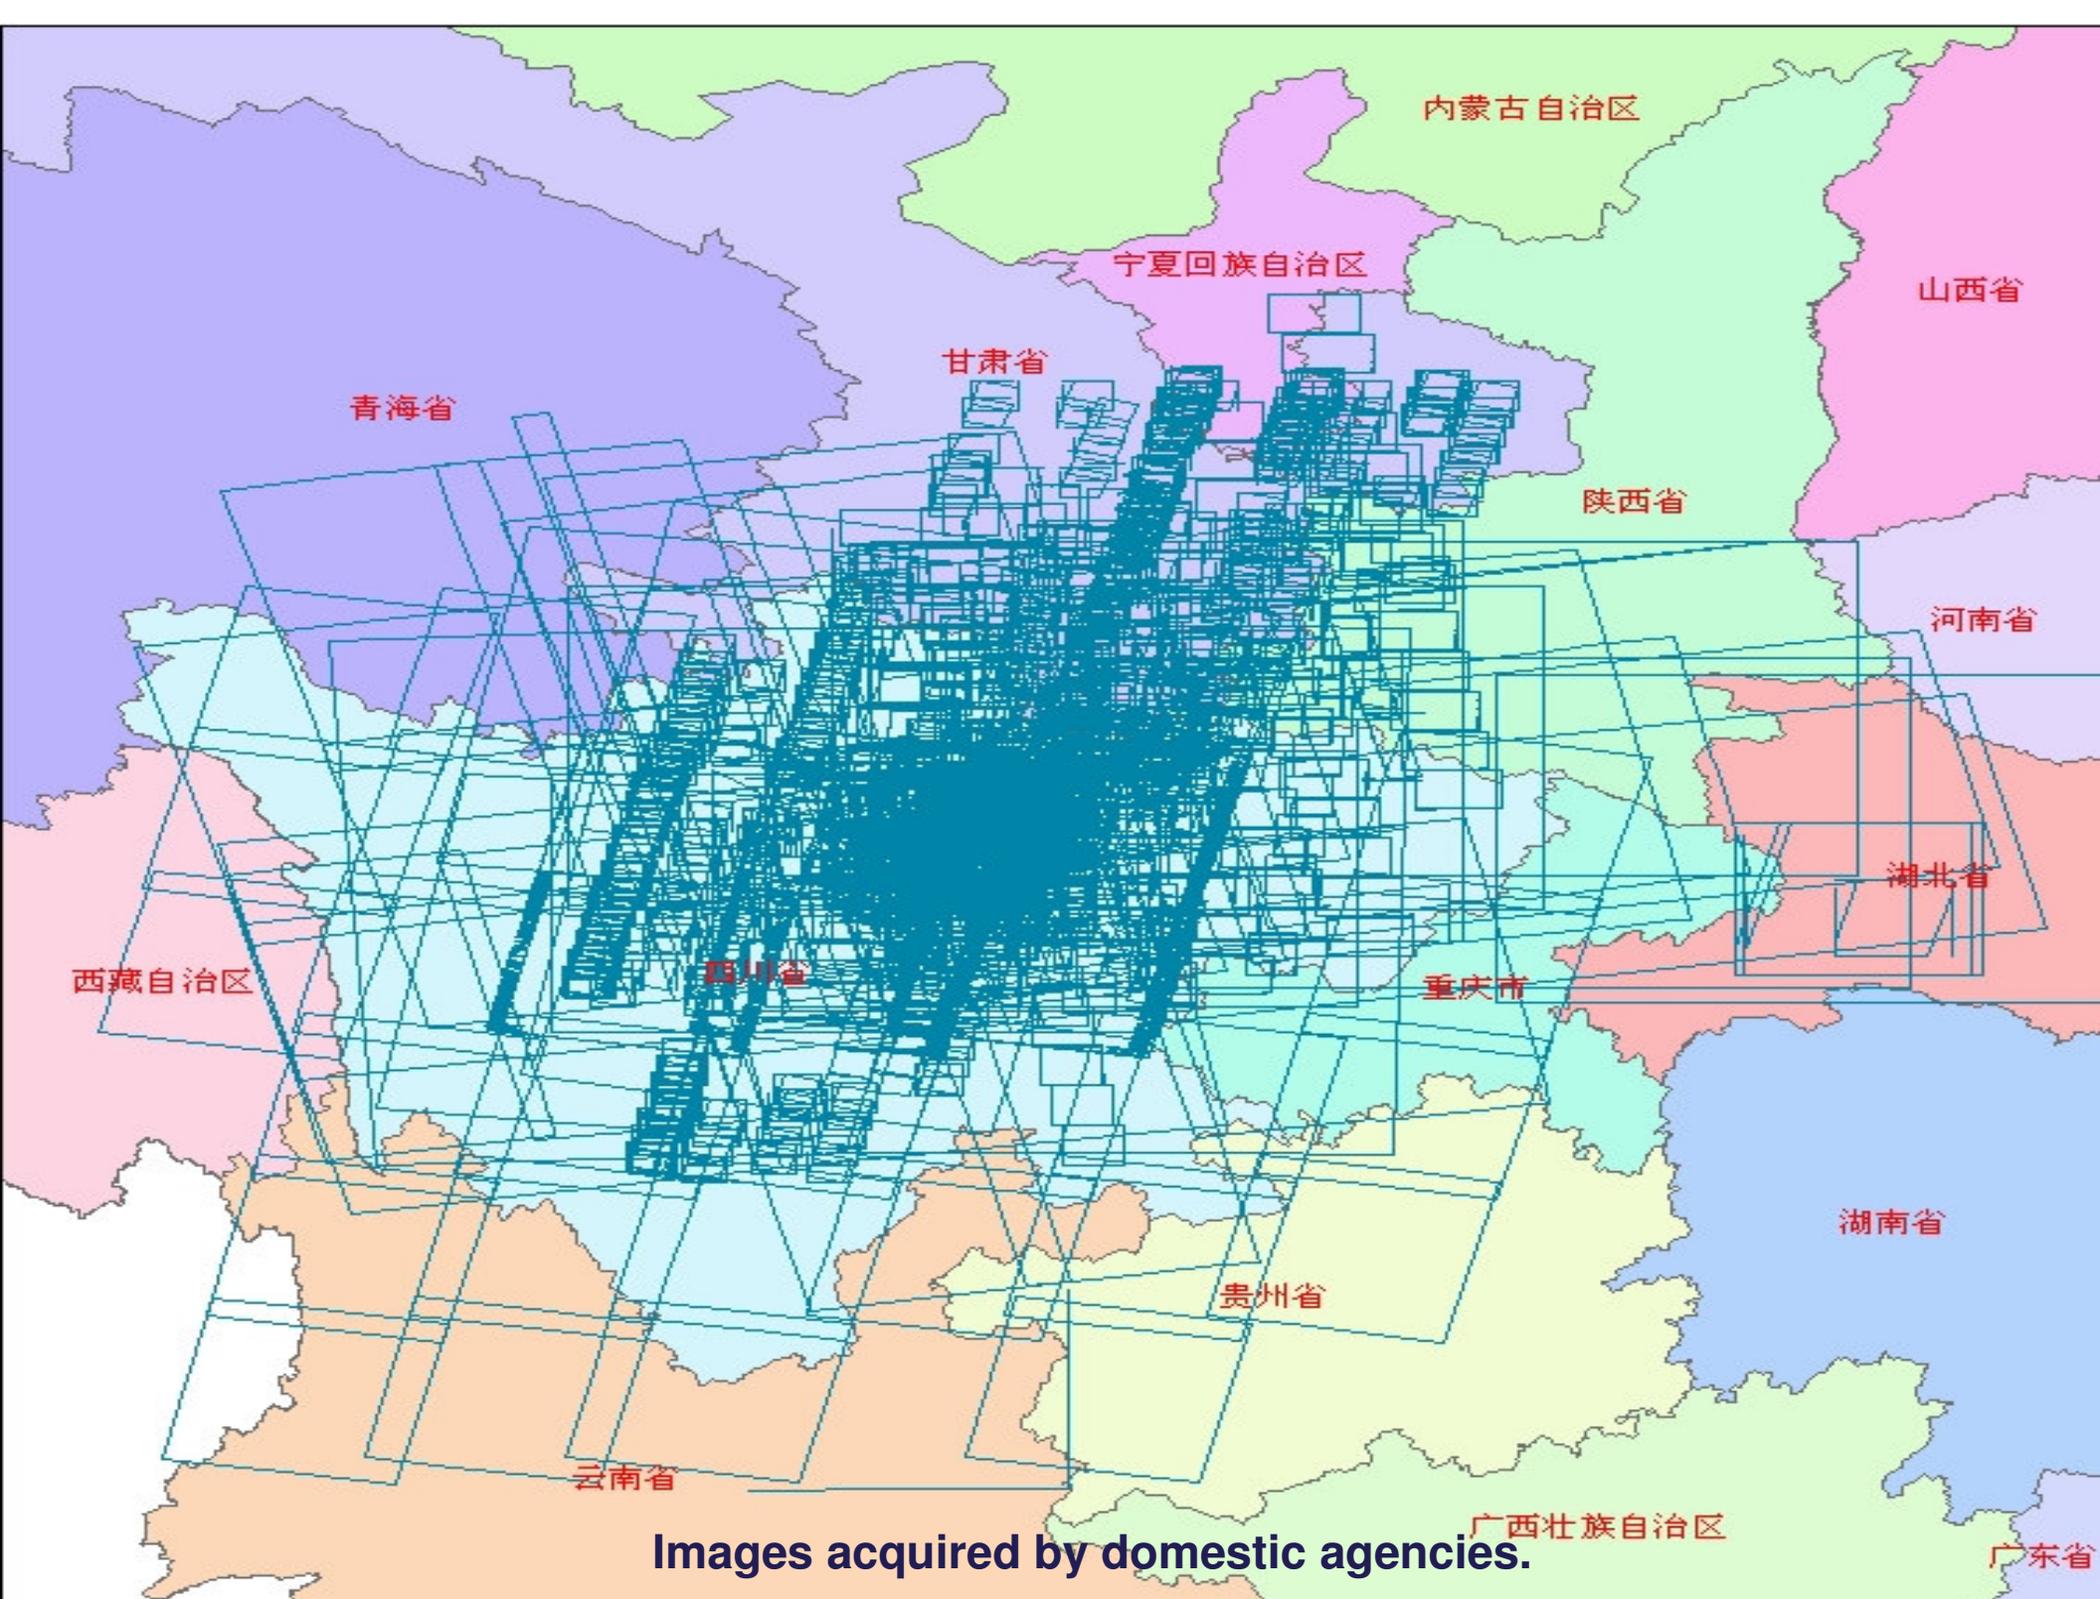
Images acquired by domestic agencies.

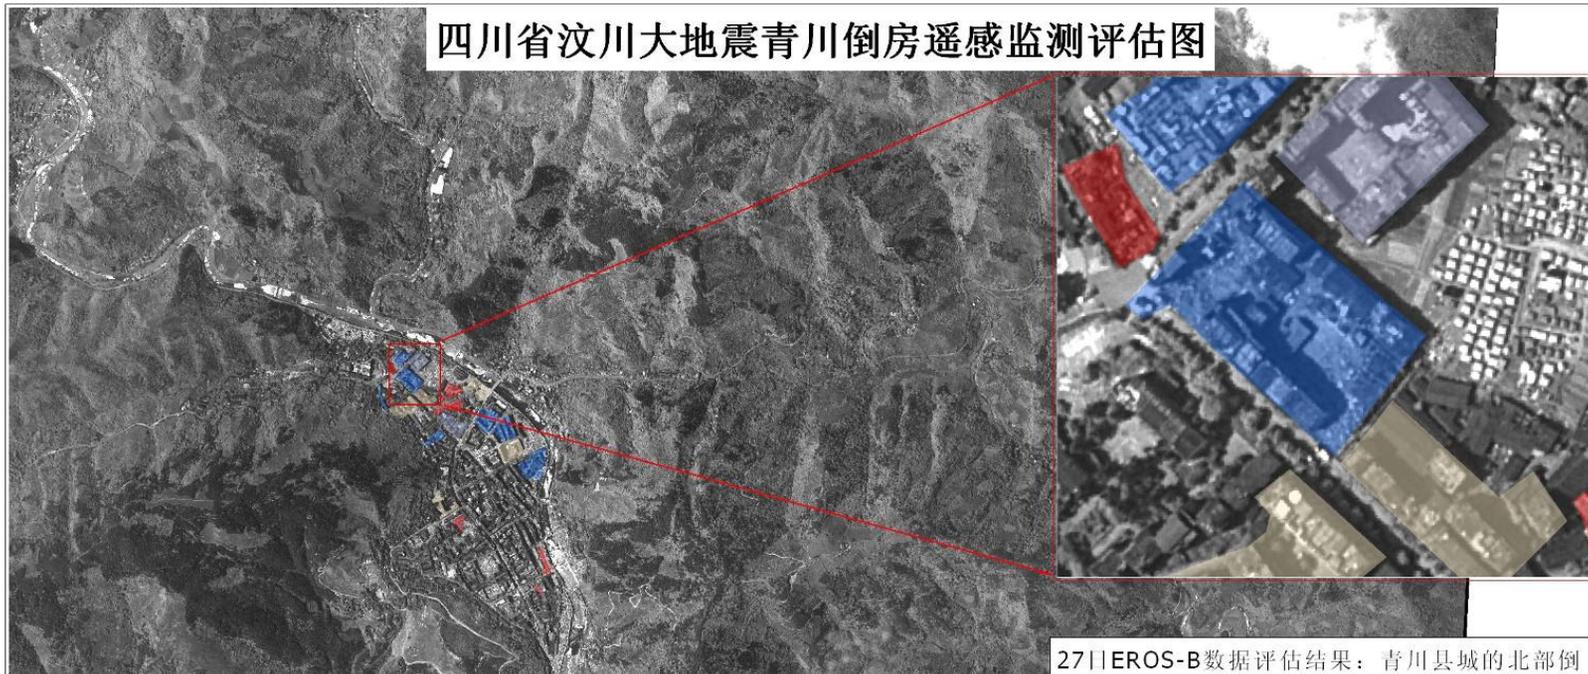
四川省汶川大地震青川倒房遥感监测评估图

27日EROS-B数据评估结果：青川县城的北部倒房较多，少部分街区的倒房率在80%以上，5%的街区倒房率在60%至80%，有10%的街区倒房率约40%至60%。

遥感数据：EROS-B

分辨率：0.6米

灾后数据：北京时间2008年5月27日

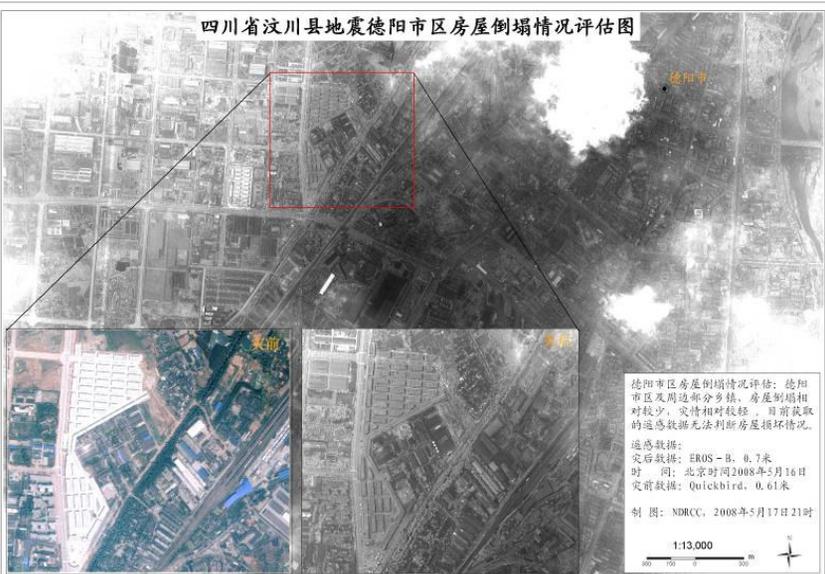
四川省汶川县地震德阳市区房屋倒塌情况评估图

德阳市区房屋倒塌情况评估：德阳市区及周边部分乡镇，房屋倒塌相对较少，灾情相对较轻。目前获取的遥感数据无法判断房屋损坏情况。

遥感数据：
 灾后数据：EROS-B，0.7米
 时间：北京时间2008年5月16日
 灾前数据：Quickbird，0.61米

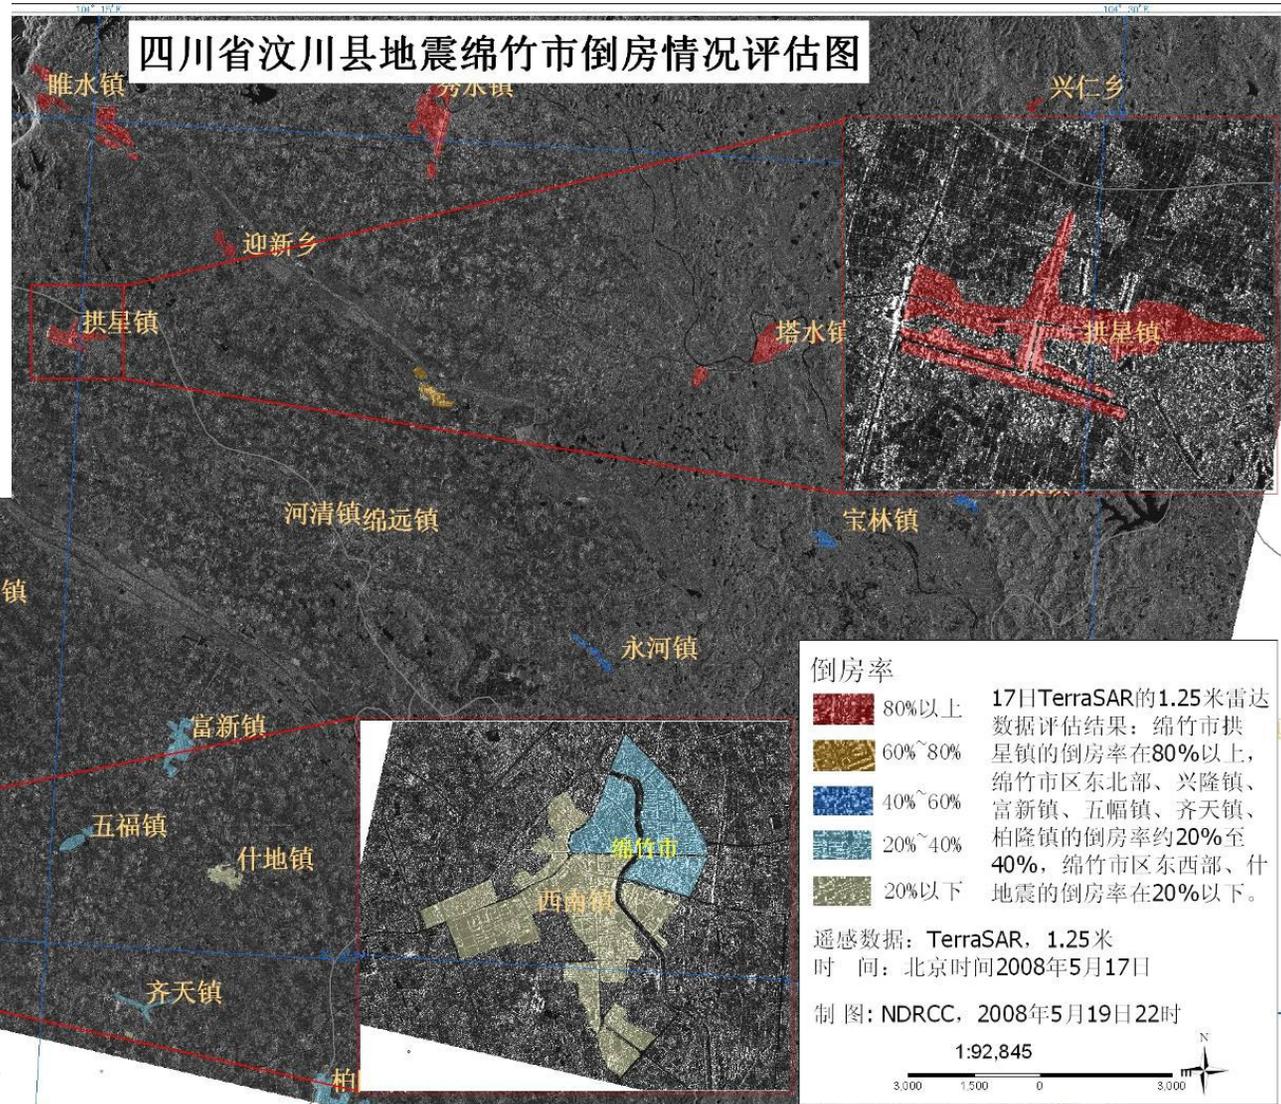
四川省汶川县地震绵竹市倒房情况评估图

17日TerraSAR的1.25米雷达数据评估结果：绵竹市拱星镇的倒房率在80%以上，绵竹市区东北部、兴隆镇、富新镇、五福镇、齐天镇、柏隆镇的倒房率约20%至40%，绵竹市区东西部、什地镇的倒房率在20%以下。

遥感数据：TerraSAR, 1.25米
 时间：北京时间2008年5月17日
 制图：NDRCC, 2008年5月19日22时
 1:92,845

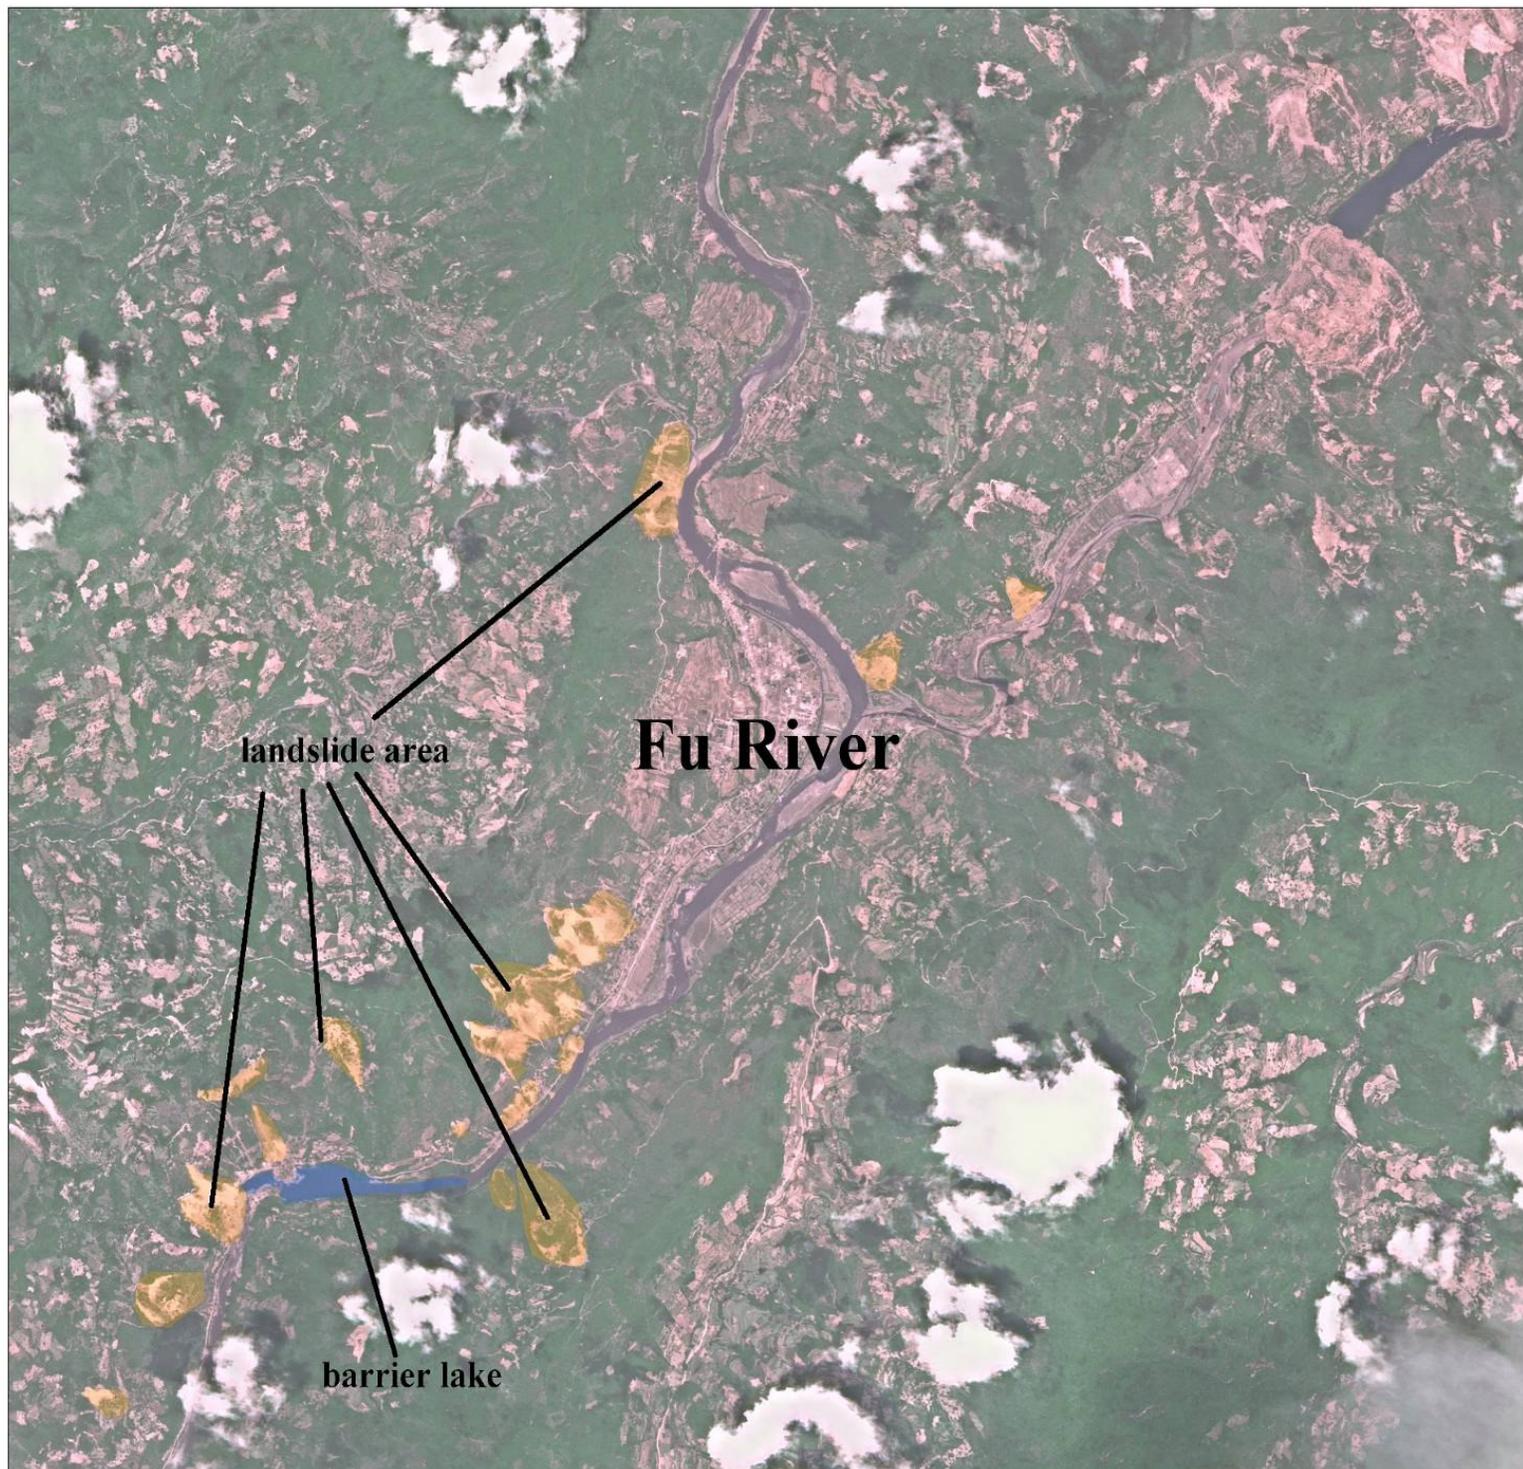
根据5月18日ALOS AVNIR-2数据评估结果: 涪江南坝镇段, 田洲村、磨湾、落河街、柘林里、沙湾、岩埂子等村的沿江地区出现十几处滑坡, 同时滑坡体堵塞河道形成堰塞湖, 加之近日降雨增多, 滑坡体形成堤坝的决堤风险很大, 当地出现泥石流次生灾害的风险增大。

The 2008 Wenchuan earthquake at a magnitude 8.0 Ms, occurred at 14:28:01.42 CST (06:28:01.42 UTC) on 12 May 2008 in Sichuan province of China, which has caused lots of landslides and barrier lake come into being. The map was based on ALOS AVNIR-2 image on May 18th in Pingwu County.

灾害影像 Disaster Image:
ALOS AVNIR-2 分辨率10m 获取时间2008年5月18日
ALOS AVNIR-2 10m acquired on 18 May 2008 © JAXA

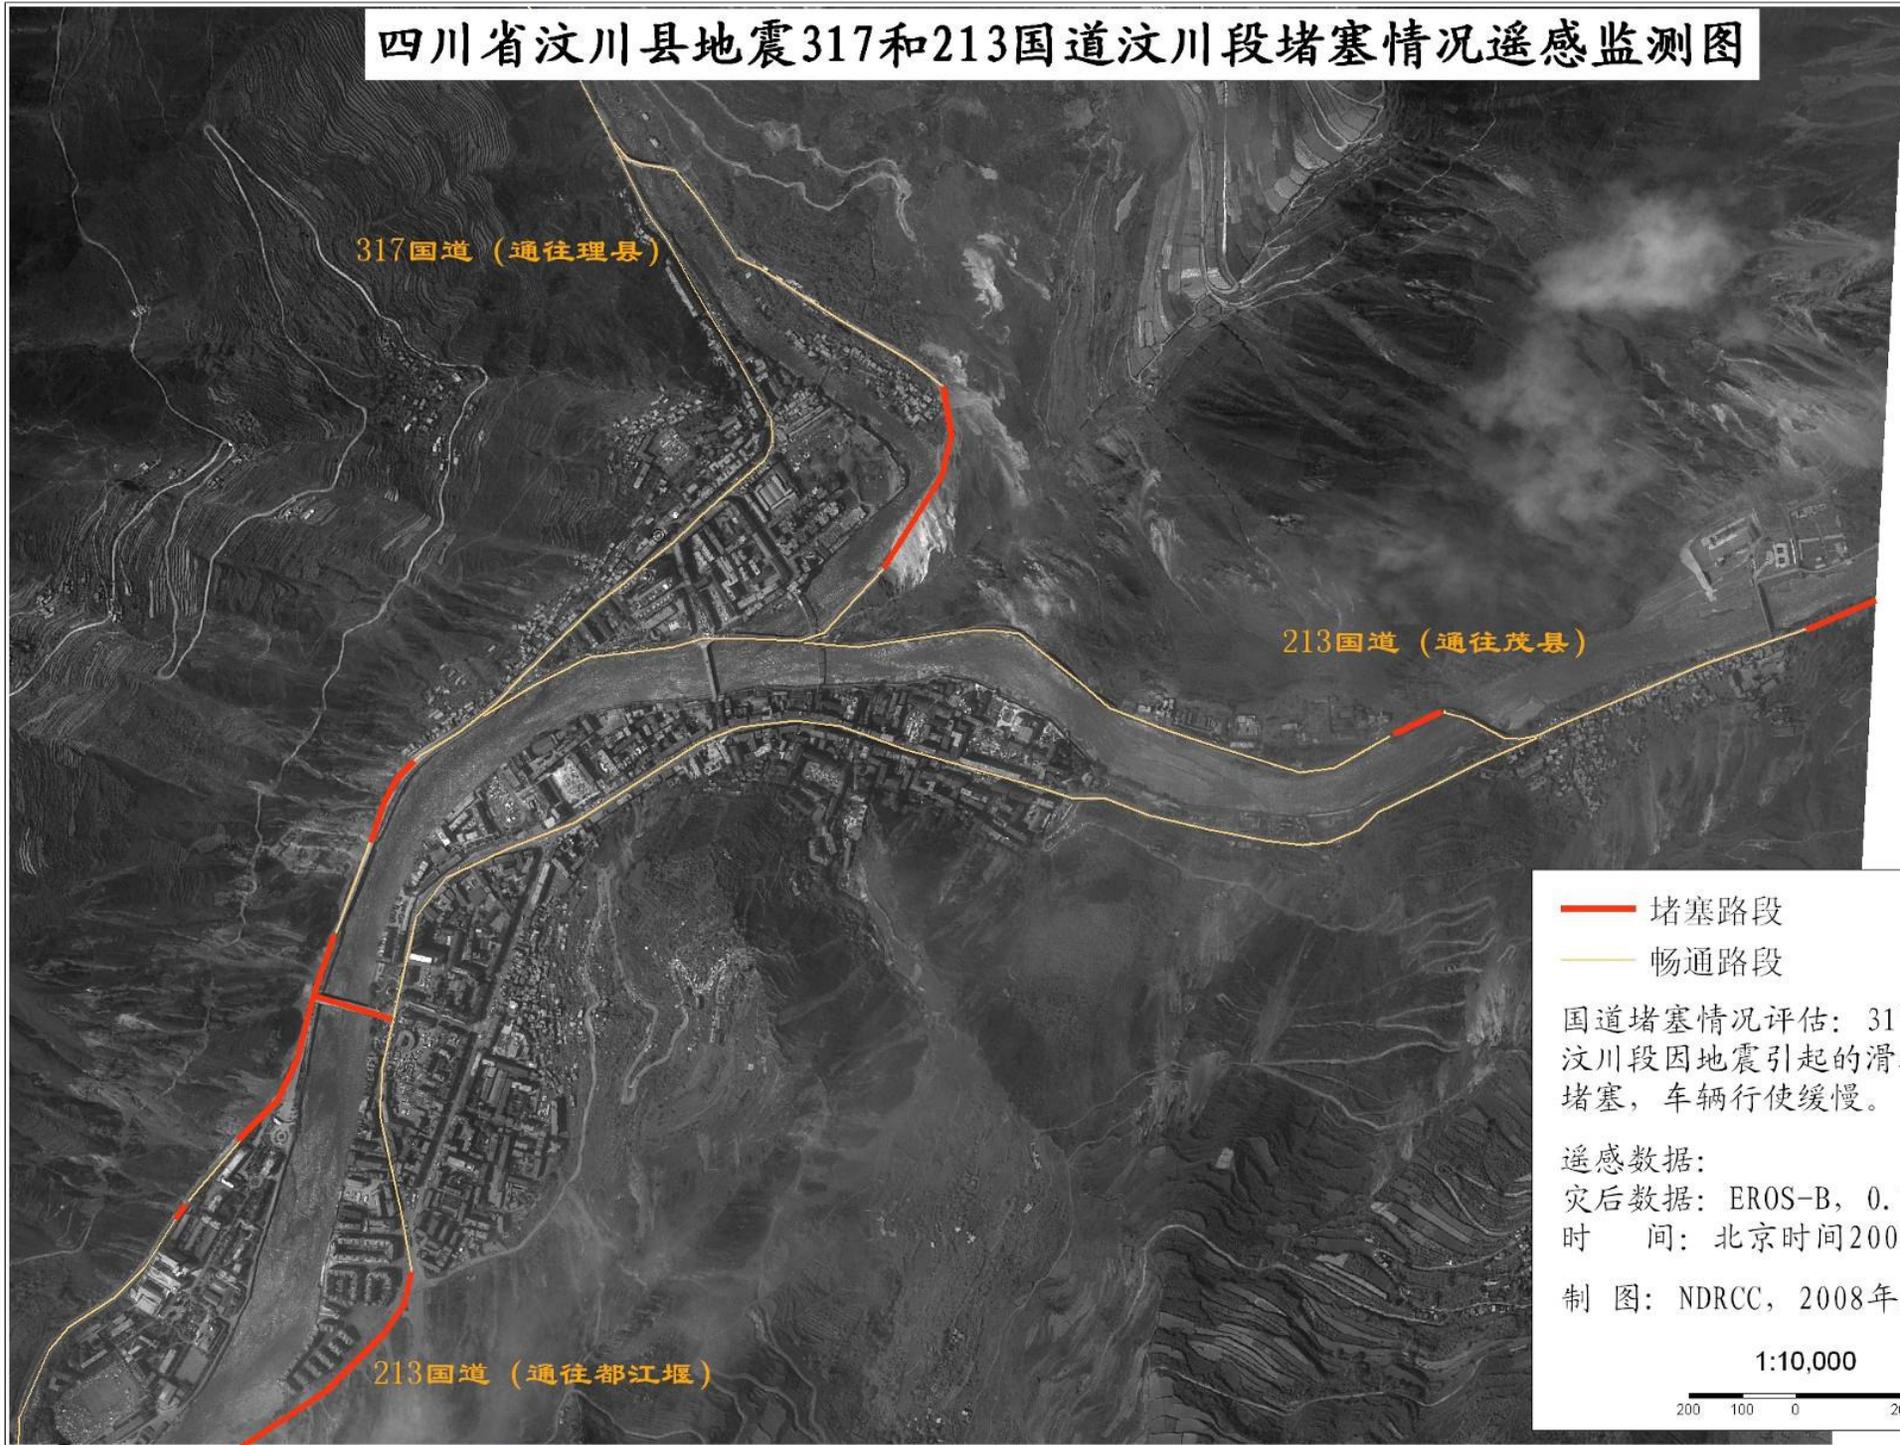
四川省汶川县地震317和213国道汶川段堵塞情况遥感监测图

国道堵塞情况评估：317和213国道汶川段因地震引起的滑坡造成多处堵塞，车辆行使缓慢。

遥感数据：
灾后数据：EROS-B, 0.7米
时 间：北京时间2008年5月16日

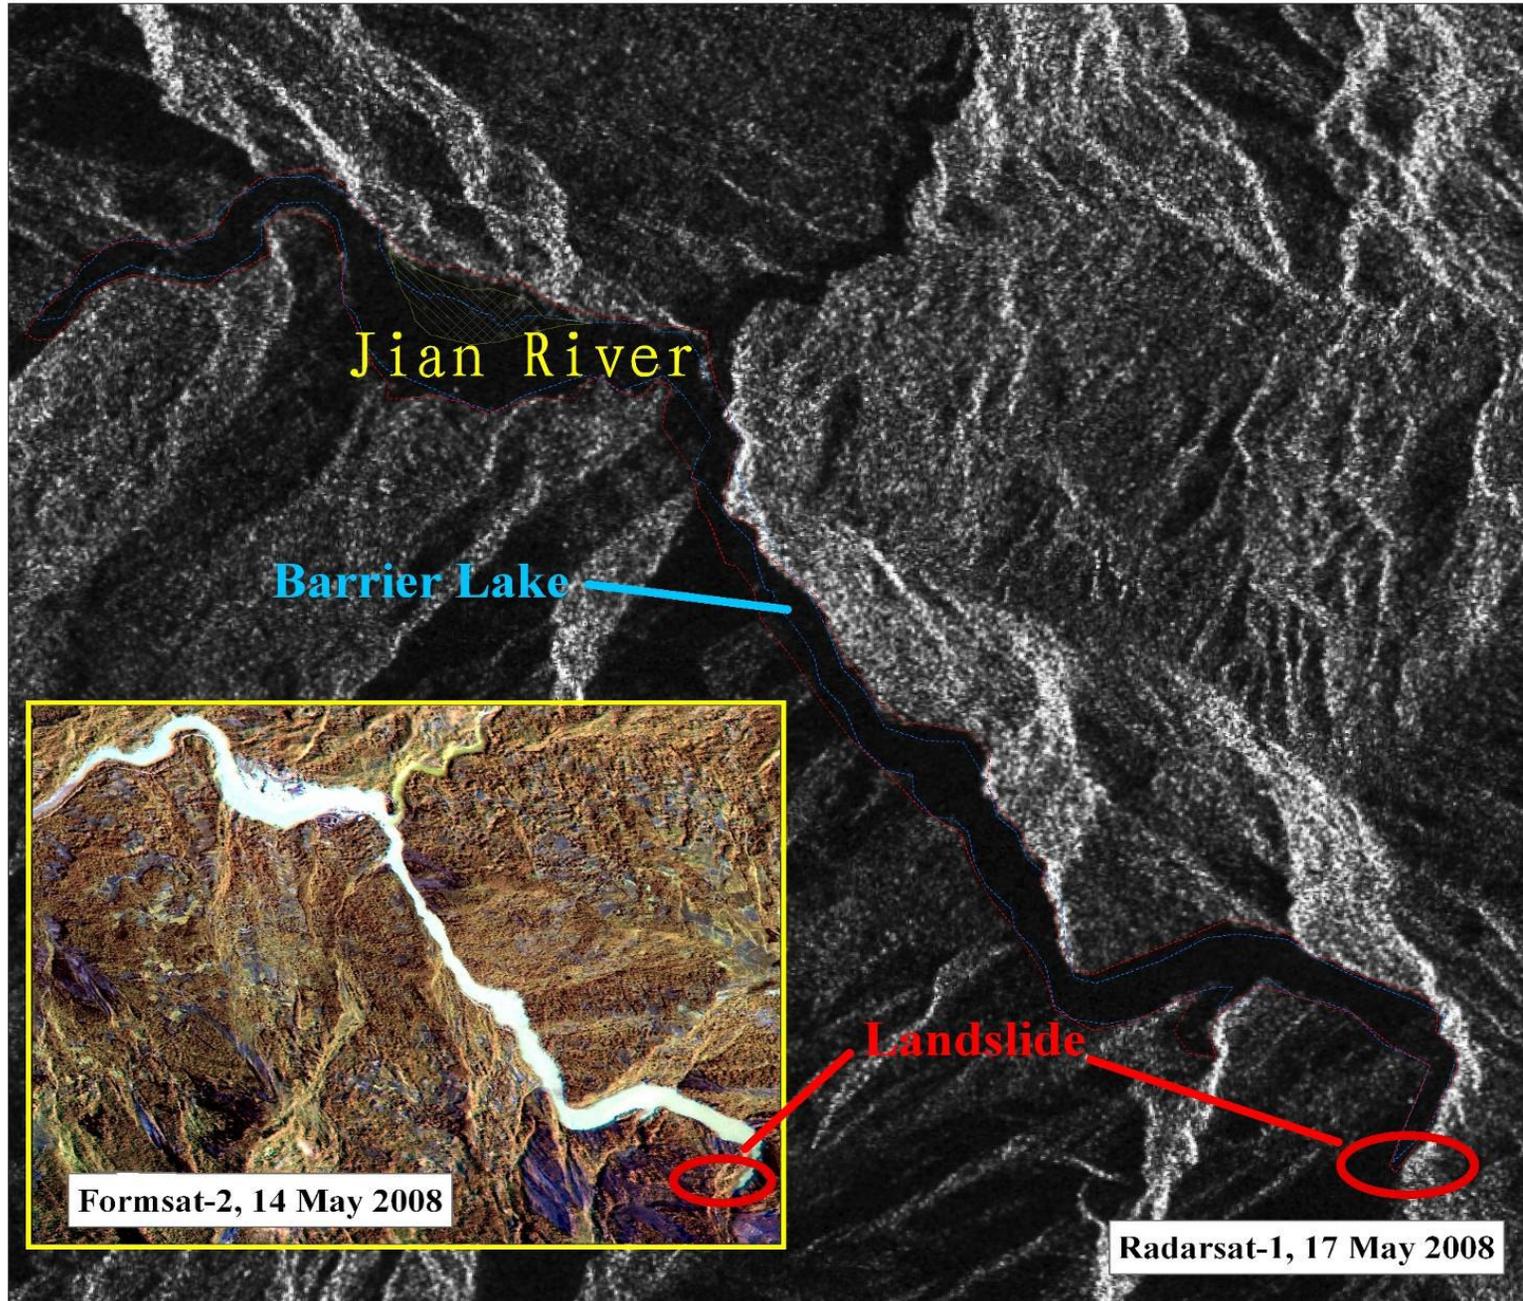
北川县唐家山堰塞湖和滑坡监测图 Barrier Lake and Landslide Monitoring Map in Beichuan County

根据5月14日福卫二号和5月17日Radarsat-1数据对堰塞湖监测结果的对比, 可见堰塞湖水面面积增加了0.4平方公里。

The 2008 Wenchuan earthquake at a magnitude 8.0 Ms, occurred at 14:28:01.42 CST (06:28:01.42 UTC) on 12 May 2008 in Sichuan province of China, which has caused lots of landslides and barrier lake come into being. The barrier lake change map was based on Formsat-2 image (on 14th May) and Radarsat-1 image (on 17th May) in Beichuan County.

- Barrier lake area based on Radarsat-1 (17 May)
- Barrier lake area based on Formsat-2 (14 May)
- Flooded village area

灾害影像 Disaster Image:
Radarsat-1 分辨率10m, 获取时间2008年5月17日
Radarsat-1 10m acquired on 17 May 2008 © CSA
Formsat-2 分辨率8m, 获取时间2008年5月14日
Formsat-2 8m acquired on 14 May 2008

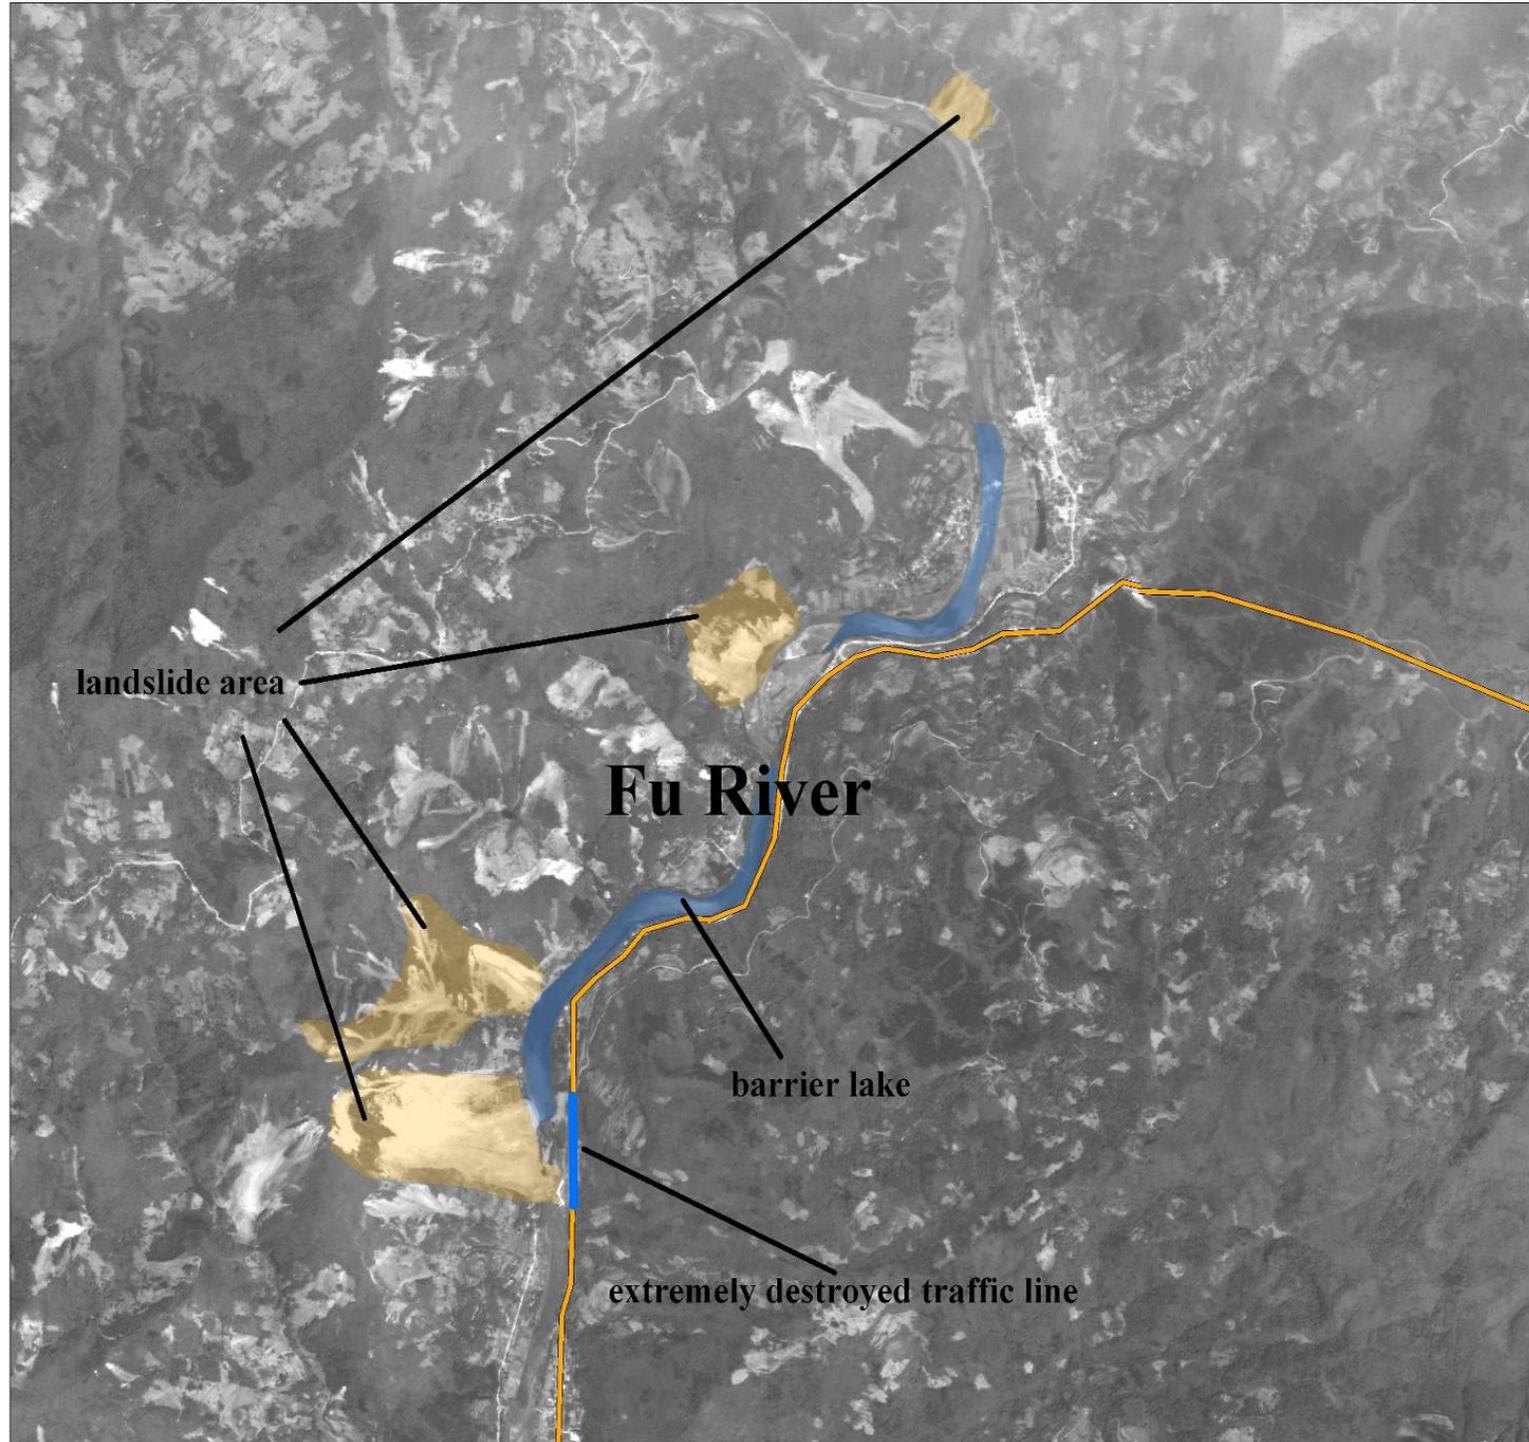
平武县平通镇滑坡和堰塞湖监测图

Monitoring Map on Landslide, Barrier Lake and Destroyed Traffic Lines in Pingtong Town, Pingwu County

根据18日ALOS PRISM数据评估结果：平通镇的太平坝、棉角村、船头河出现多处滑坡，造成省道南遂线部分路段严重损坏，给当地的交通和救援造成较大困难，同时滑坡体堵塞河道形成堰塞湖，加之近日降雨增多，滑坡体形成堤坝的决风险很大，当地出现泥石流次生灾害的风险增大。

The 2008 Wenchuan earthquake at a magnitude 8.0 Ms, occurred at 14:28:01.42 CST (06:28:01.42 UTC) on 12 May 2008 in Sichuan province of China, which has caused lots of landslide disasters, traffic line destroyed and a barrier lake came into being. The map is based on ALOS PRISM image on May 18th in Pingtong Town, Pingwu County.

灾害影像 Disaster Image:
ALOS PRISM 分辨率2.5m 获取时间2008年5月18日
ALOS PRISM 2.5m acquired on 18 May 2008 © JAXA

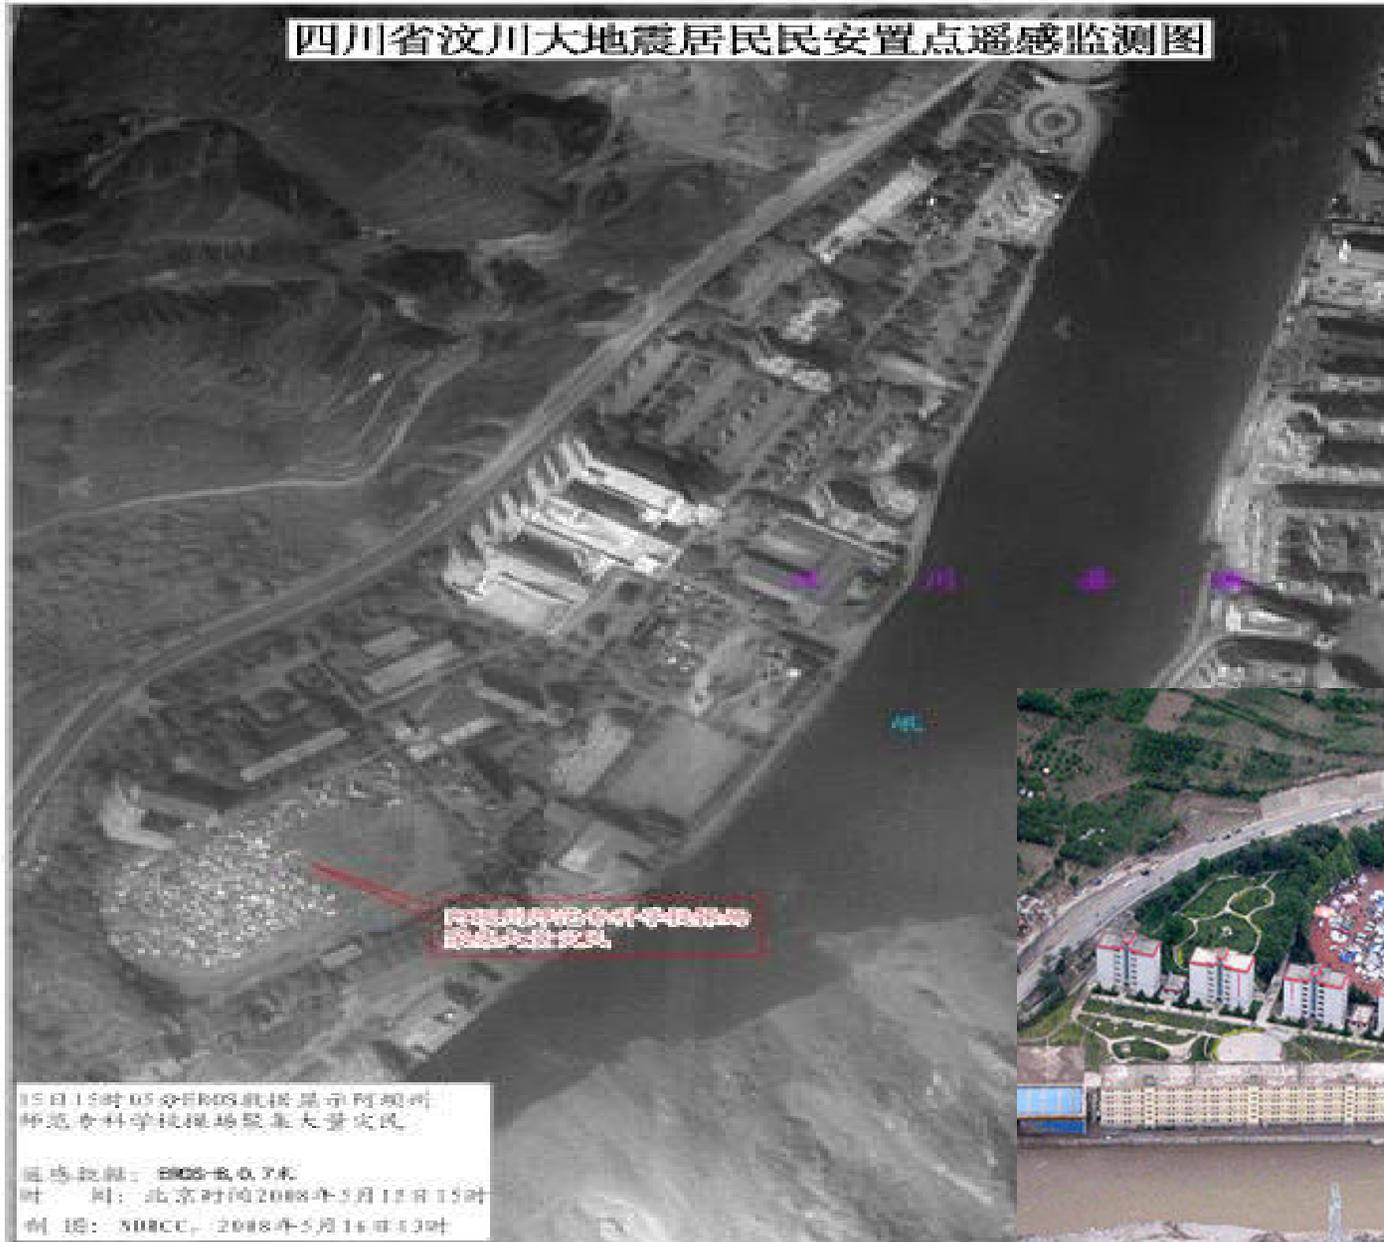
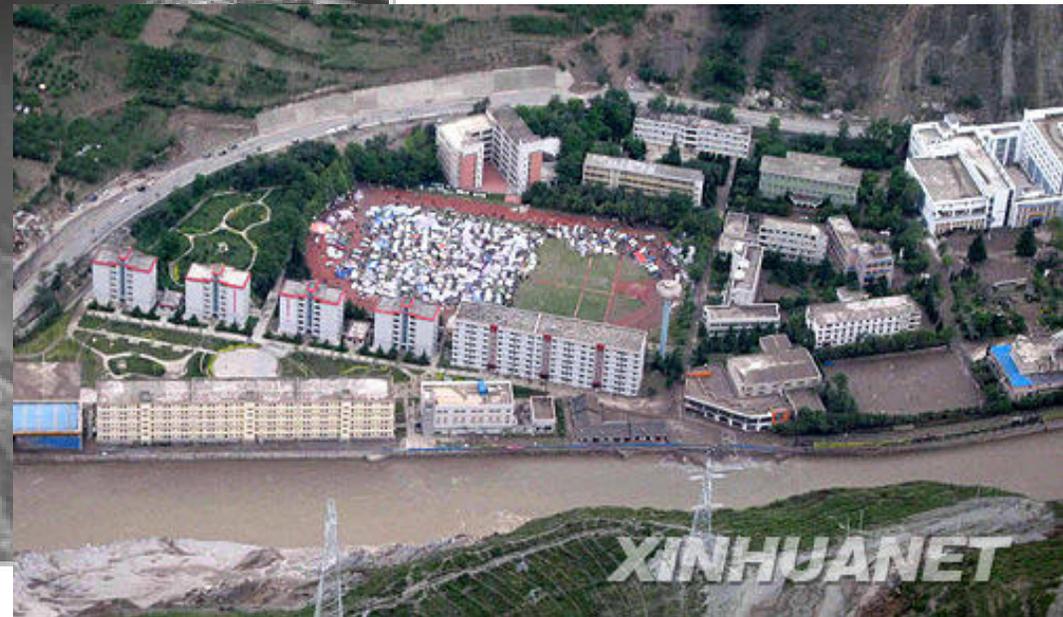
四川省汶川大地震居民安置点遥感监测图

Evacuated Tents Monitoring
