Space Technology Application for Wenchuan Earthquake Relief

Dr. Li Suju

National Disaster Reduction Center of China
Feb 13, 2009 Vienna

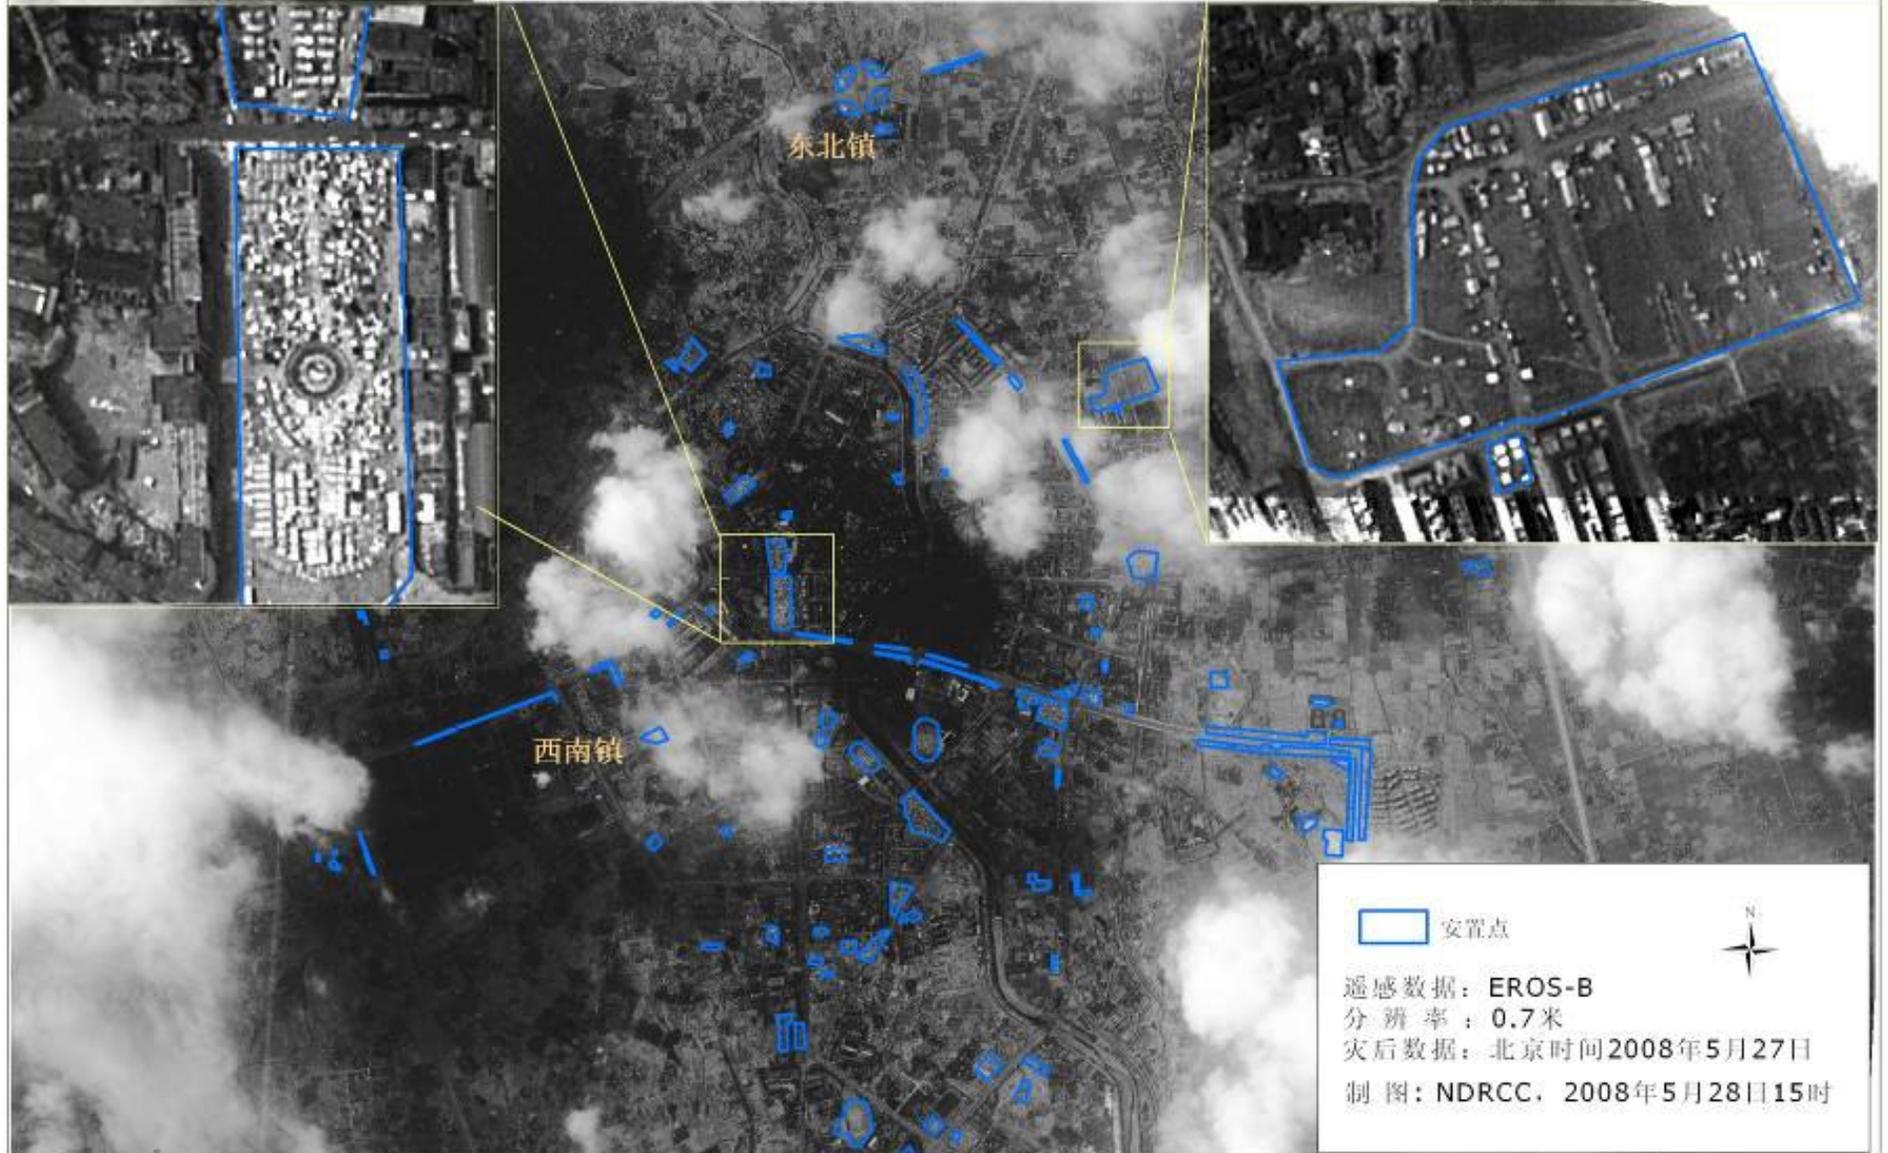
四川省汶川大地震绵竹灾民安置点遥感监测图

Evacuated Tents Monitoring
