A Summary of the Galaxy 15 Incident and its Impact on Space Sustainability

Brian Weeden
Technical Advisor
Secure World Foundation

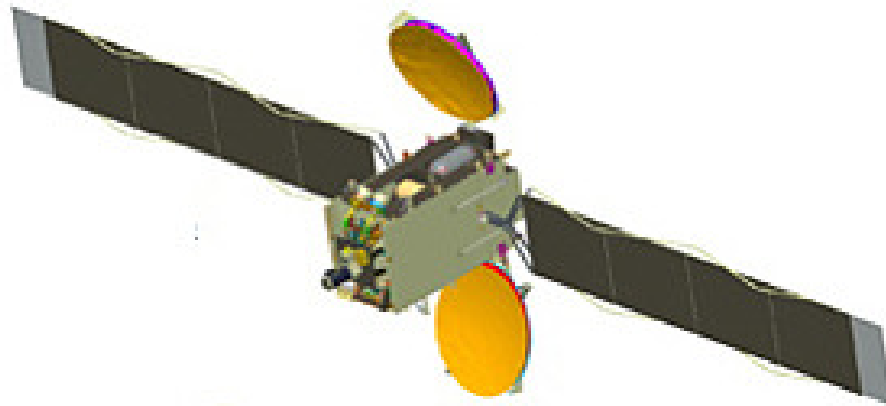
*The Star-2 Satellite Bus
Credit: Orbital Sciences*

- April, 2010, Galaxy 15 stopped responding to commands and transmitting telemetry
- Galaxy 15's communications payload remained active and was able to rebroadcast any C-band signals it received while drifting
 - “Open microphone”

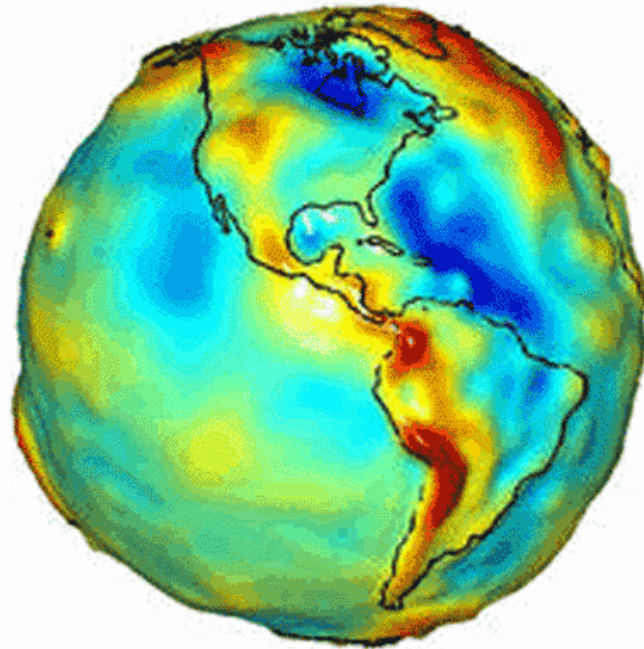
*Gravitational Map generated by GRACE satellite
Credit: NASA*

- All satellites in the GEO belt are pulled east or west from their assigned orbital slots by variations in the Earth's gravitational field

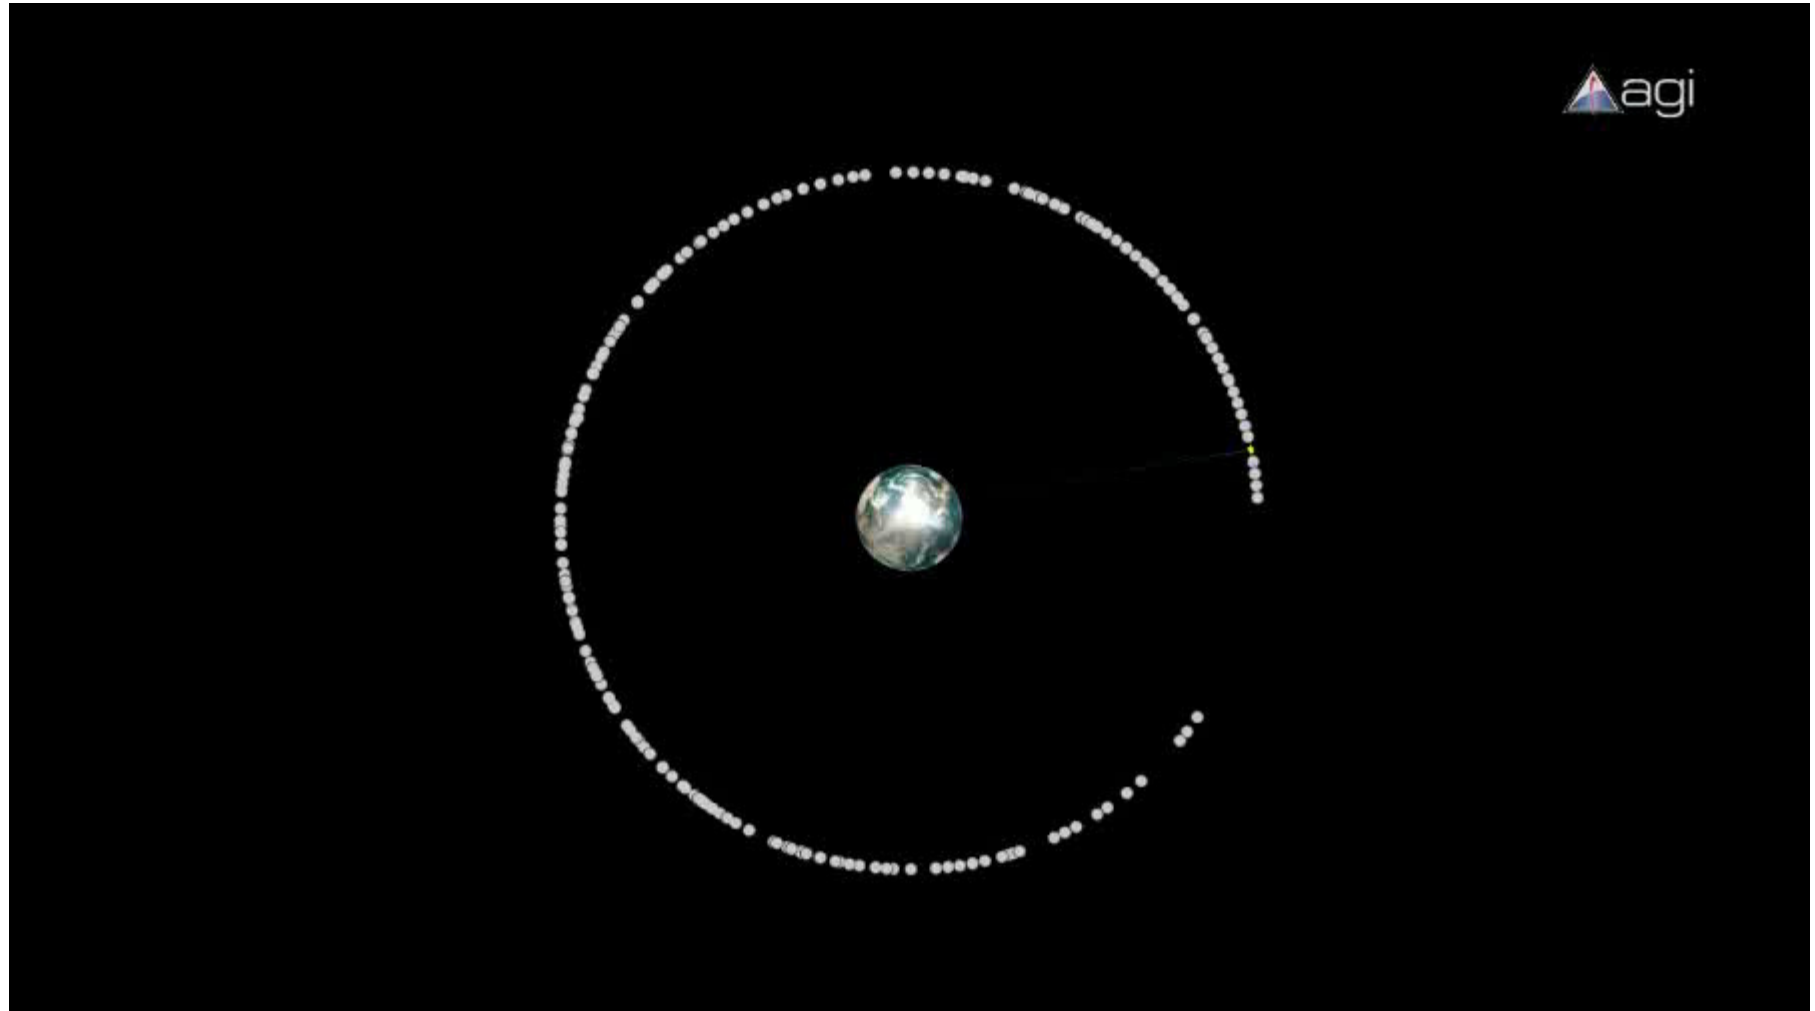
- Between May and December, 15 maneuvers were conducted by other satellites
- Mitigation Team
 - Intelsat
 - SES
 - SatMex
 - Telsat Canada
 - Orbital Sciences

- Galaxy 15 drifted past SES-1 satellite from 4-18 Dec, 2010
 - SES-1 relays data from several US weather tracking and forecasting satellites to US National Weather Service (NWS)
 - Interference from Galaxy 15 caused a brief outage with the satellite data feed on 6 Dec
