MINISTÉRIO DA CIÊNCIA, TECNOLOGIA, INOVAÇÕES E COMUNICAÇÕES
INSTITUTO NACIONAL DE PESQUISAS ESPACIAIS

Disaster management support at INPE: Brumadinho Dam Collapse

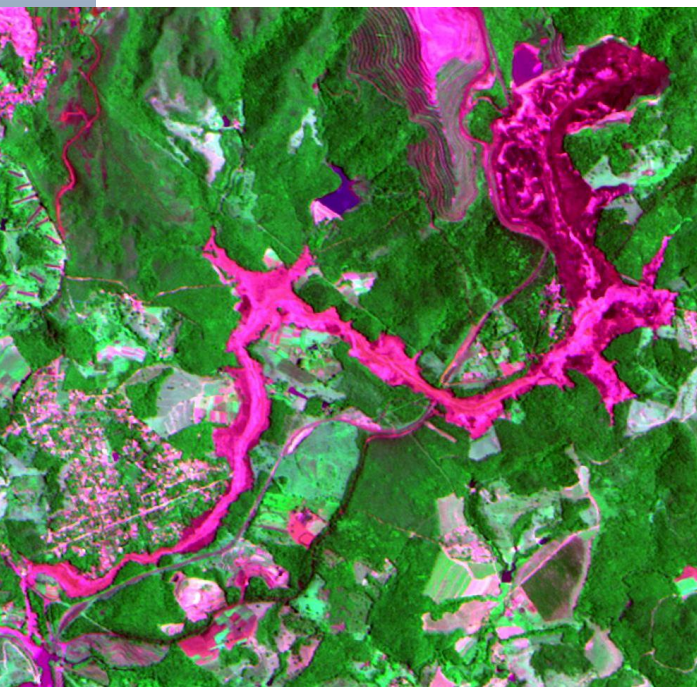
Titan2D

- In addition, it was generated a dynamic simulation using the Titan2D, a computer program developed by the GMFG (Geophysical Mass Flow Group) at State University of New York for the purpose of simulating granular avalanches over digital elevation models of natural terrain.
